**Nomination Form  
Anadromous Waters Catalog**

Anadromous Waters Catalog Number of Water Body 191-20-13800-2030

## 191-20-13800 Tributary 3

**ADDITION**

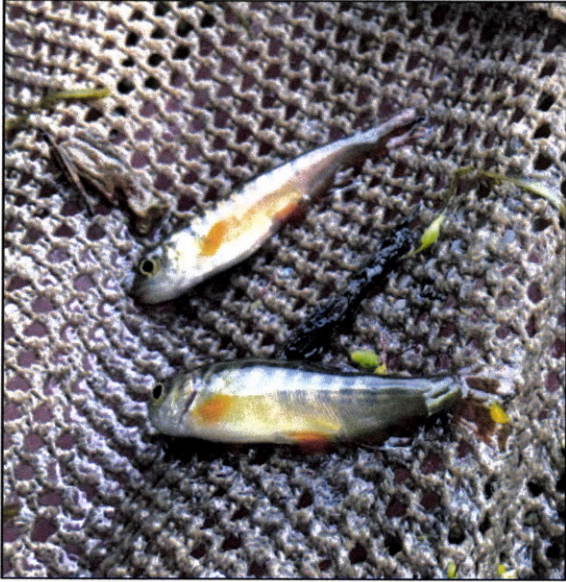
**Figure 1.—Juvenile coho salmon caught at waypoint 753.**

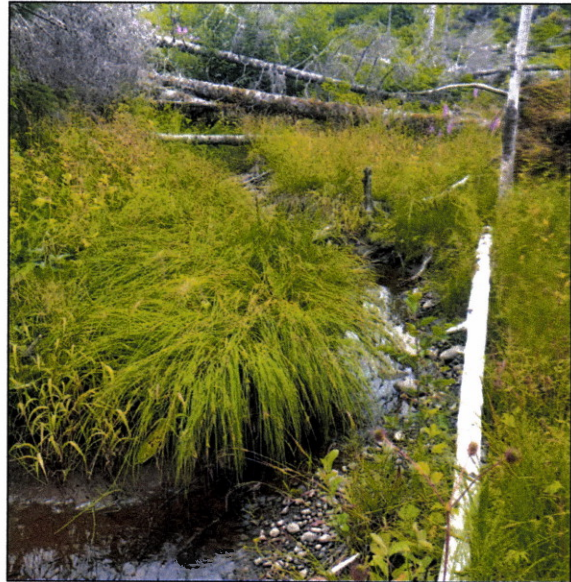
**Figure 2.—Looking upstream at waypoint 753.**

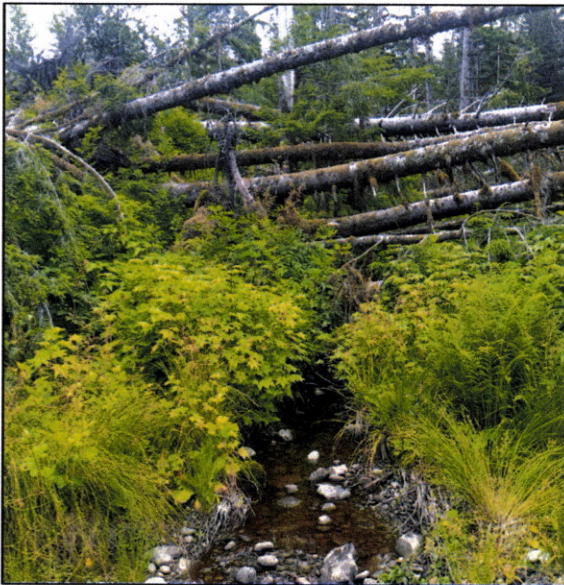
**Findings:** We surveyed this uncataloged stream using a backpack electrofisher and GPS and captured juvenile coho salmon. This stream meanders through open wetlands with good flow and a mixture of small gravels and fine organic substrate. The forested buffer has blown into the stream in several places as the channel crosses the road, with significant blowdown and woody debris upstream of the road. A puncheon bridge is present at waypoint 761 with evidence of heavy erosion and leading to poor fish passage. We were not able to survey beyond waypoint 761 due to time but fish habitat likely continues (Table 1; Figures 1–4).

**Figure 3.—Buffer blown into the stream channel at waypoint 755.**

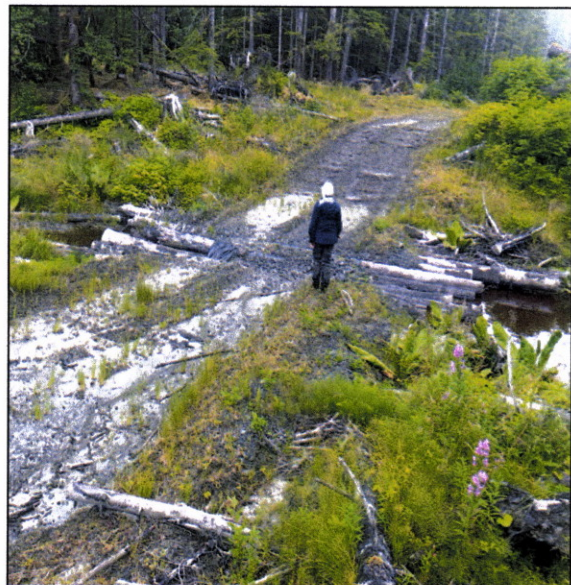
761	59.977462	-141.639355	Stream flows opposite of what's drawn. This is headwaters of stream to west. Log bridge not constructed, puncheon still here. Massive road erosion seen. Bunch of trees fell over the creek just downstream. Poor for fish passage and affecting the stream itself. Needs to be addressed. Lots of input material from roadbed.					VI	2 CO

**Figure 4.—Puncheon bridge at waypoint 761.**
