**State of Alaska  
Department of Fish and Game  
Sportfish Division**

**Nomination Form  
Anadromous Waters Catalog**

## Anita Bay Uncataloged Stream

**ADDITION**

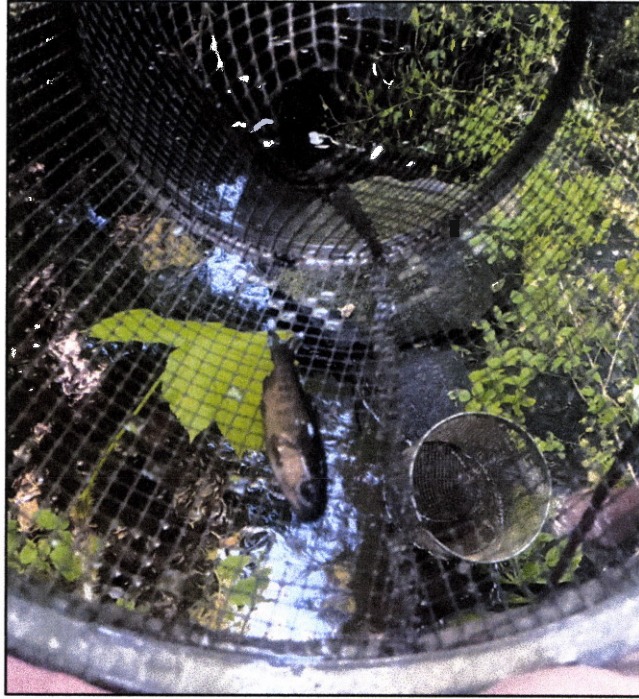
Figure 1.—Juvenile coho salmon caught at waypoint 1000.

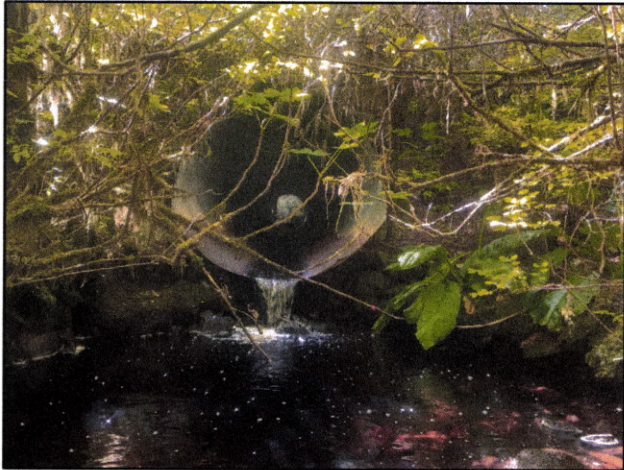
**Findings:** We surveyed this uncataloged stream from the road using baited minnow traps, a backpack electrofisher and GPS and captured juvenile coho salmon, Dolly Varden, and cutthroat trout. This stream crosses the road at waypoint 1000 via a 6ft metal corrugated culvert that is perched 1ft at the outlet. Riprap has fallen into the stream at the inlet of the pipe blocking normal stream flow and likely fish passage as well. No anadromous fish were caught above the pipe. Upstream from the pipe, the stream flows at a moderate gradient around 4% with abundant spawning substrate and quality rearing habitat. Downstream of the pipe, the stream has predominantly cobble and boulder substrate before flowing into the intertidal. (Table 1; Figures 1–3)

Figure 2.—Perched culvert at waypoint 1000.

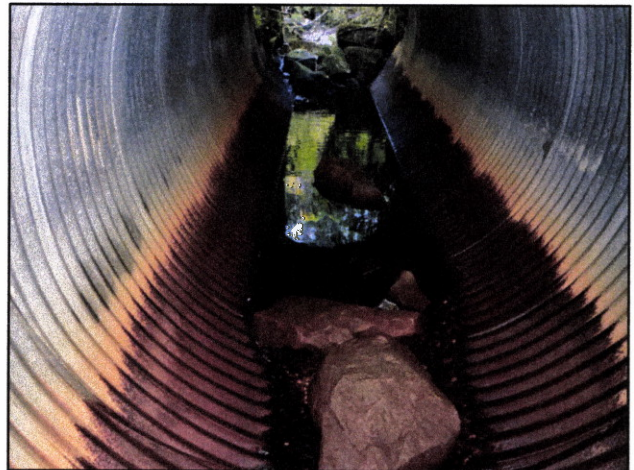
Figure 3.—Inlet of culvert with fallen rip rap blocking the channel and fish passage at waypoint 1000.
