# Alaska Department of Fish and Game

Habitat Section  
Southeast Region

## 182-70-11600 Tributary 1

**Survey date:** 9/14/2024

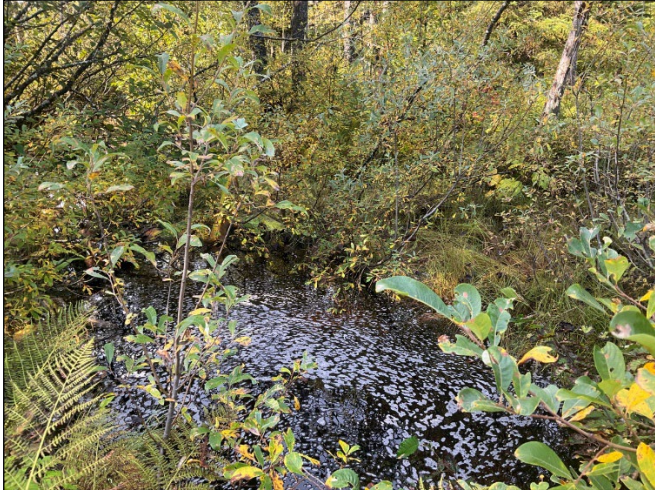
**Findings:** We surveyed this uncataloged stream from the road using baited minnow traps and GPS and captured juvenile coho salmon (Figure 1). The stream is low gradient but the culvert appears to be undersized for the stream channel (Table 1; Figures 2, 3). A culvert survey and future investigation upstream is recommended.

Figure 2.—Channel downstream of the culvert.

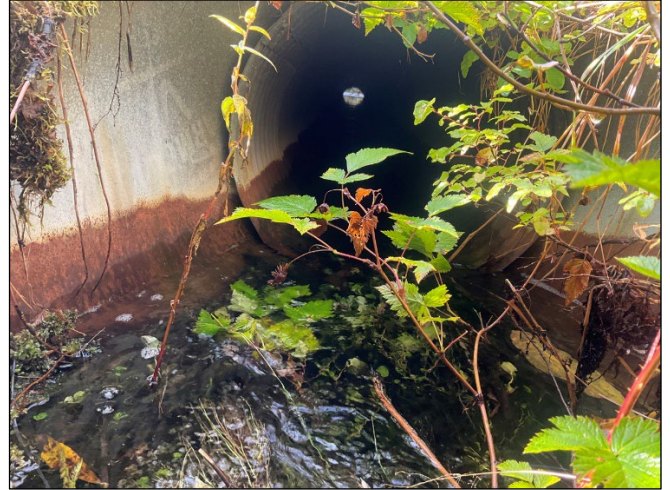
Waypoint	Latitude	Longitude	Notes	Stream Width ft	Stream Substrate	Habitat Features	Gradient %	Sample Effort	Sample Results
1228	59.517840	-139.280001	2-3ft CMP buried and submerged. Fine organic substrate more prevalent upstream of the pipe. Stream flowing through vegetated channel. No fish captured could be worth EFin. USFS has documented coho presence.	2-4	Large Gravel Sand		0-1	MT	No Fish
1229	59.516682	-139.276478	Water ponded up and downstream of the road. 2ft CMP almost fully submerged downstream. Water flowing into pipe upstream.		Fine Organic		0-1	MT	
1231	59.516649	-139.276529			Fine Organic				2 CO
1232	59.516334	-139.275503	2ft CMP. Covered in moss. Water ponded downstream of the pipe and flowing in vegetated channel upstream of the pipe.		Fine Organic Large Gravel		0-1		No Fish

Figure 3.— Inside of culvert looking downstream.
