Alaska Department of Fish and Game

Habitat Section
Southeast Region

186-15-10400 Tributary 1

ADDITION

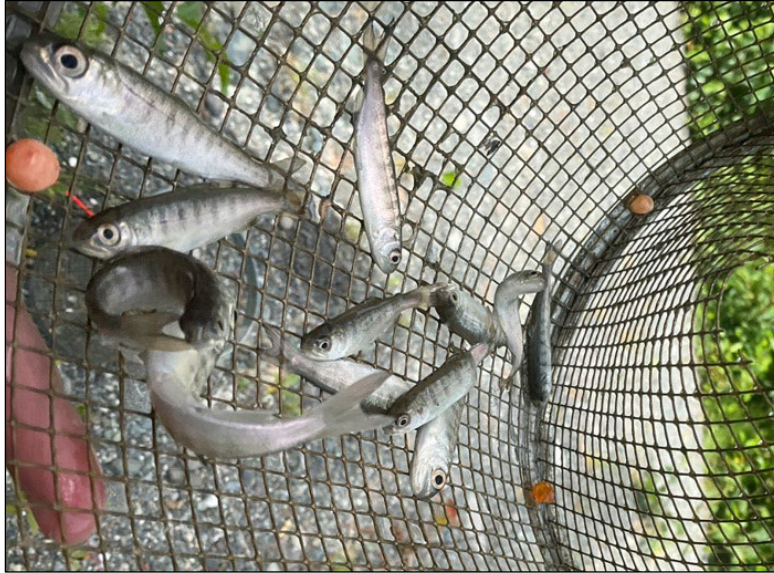
Findings: We surveyed this uncataloged stream using baited minnow traps and GPS and captured juvenile coho salmon. This stream crosses under the road via two 24 inch culverts at waypoints 662 and 661. Coho were caught below the pipe only at waypoint 662; water velocity was high and may act as a barrier. Flow is from the highly mobile system in the forest. Stream path continues to the new reroute of Watson Creek confirmed via drone (Table 1; Figures 1–3).

Figure 1.—Juvenile coho salmon caught at waypoint 662.

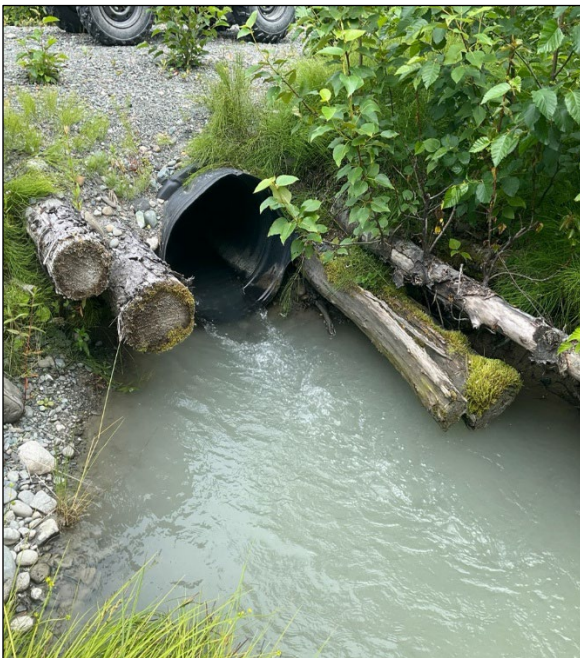
Figure 2.—Culvert outlet at waypoint 662.

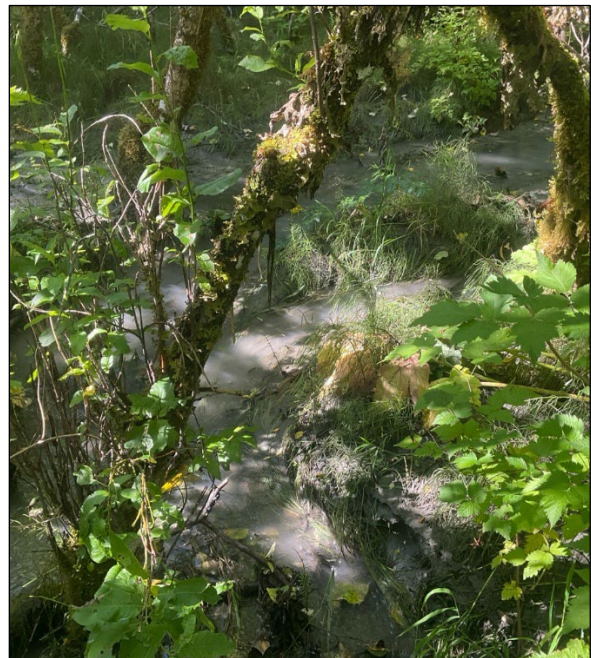
1085	59.985328	-141.566907	Still multiple braids with flowing water throughout the forest, very salty. No fish scene down to this point.		Silt				No Fish
1086	59.984531	-141.566293	Forest is a braided mess of small silty channels. Can't follow just one. No fish seen. Likely recently flooded this area. Goes all the way south to road.		Silt		1-2	EF	No Fish

Figure 3.—Braided forest channels at waypoint 1085.
