# Alaska Department of Fish and Game

## 186-15-10550-2005-3002 Tributary 1

## ADDITION

**Survey date:** 8/20/2024

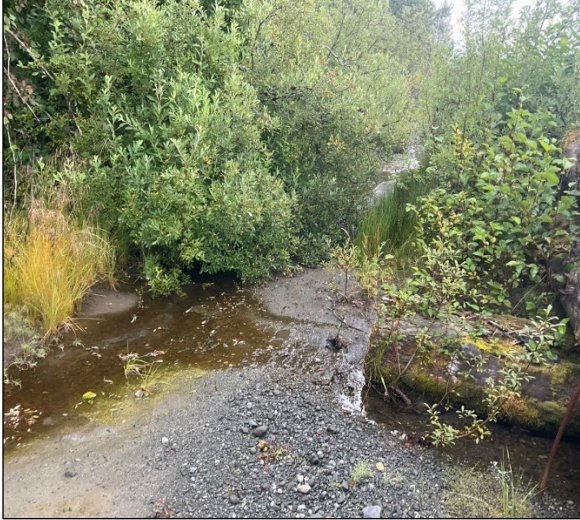
Figure 1.—Upstream at waypoint 1046.

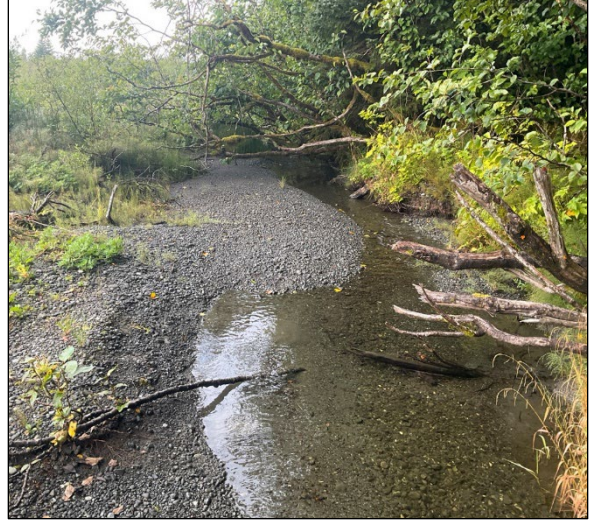
1044	59.986956	-141.524153	24 inch smooth wall pipe with little flow at outlet. Inlet of pipe cannot be found, but is likely covered by sediment, buildup or woody debris, but still allows a small amount of water flow through the pipe. Extend the ditch to the next channel.		Small Gravel		1-2	VI	3 CO
1046	59.987137	-141.523637	Coho caught in pool just upstream of the bridge and others visually seen. The ditch further west continues up through this point and continues going east. Only small amount of water falling under the bridge to low water levels.		Small Gravel		1-2	EF	2 CO

Figure 2.—Downstream at waypoint 1044.

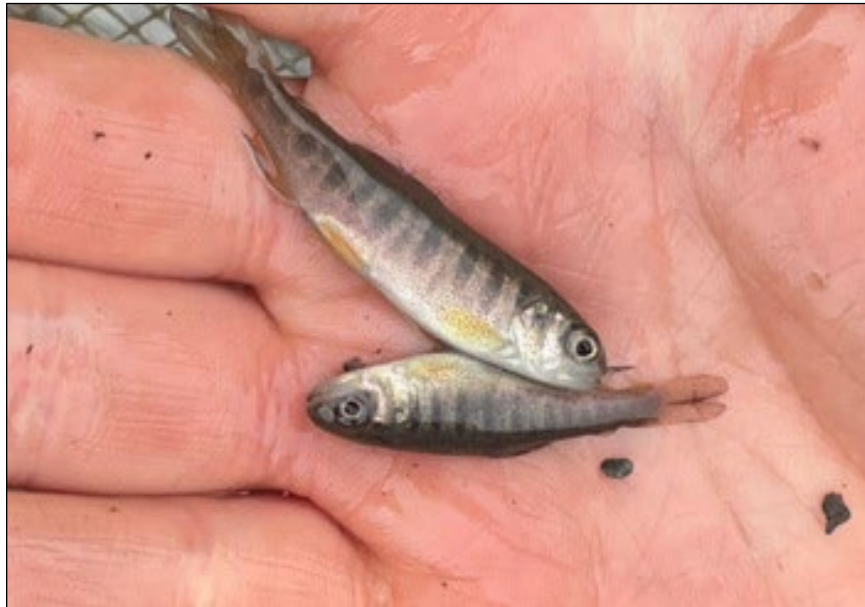
Figure 3.—Juvenile coho salmon caught at waypoint 609.
