Alaska Department of Fish and Game

191-20-13400-2033

CORRECTION

Water body name: Lydick Creek

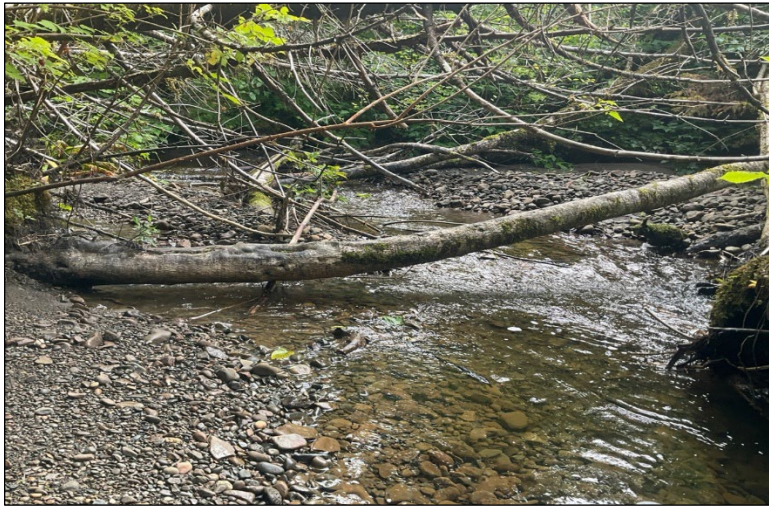
Figure 1.—Looking upstream at waypoint 1181.

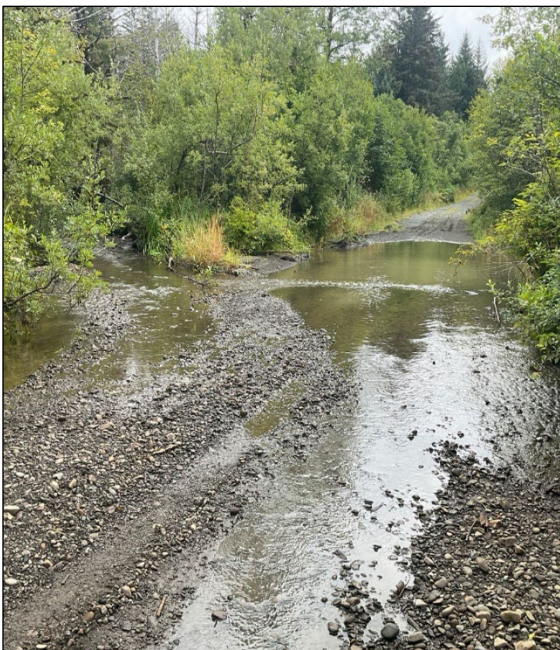
Findings: We surveyed this cataloged stream using a backpack electrofisher and GPS and found that the stream path is incorrectly mapped. We visually identified juvenile coho salmon. This stream has changed routes starting at waypoint 1182; it now meanders west. The main flow parallels the road and crosses under a bridge at waypoints 1184 and 1185 and continues to run south. We used a drone to attempt to map the route south of the road, but vegetation made it difficult to track; it seems to join with 191-20-13400-2033-3005-4010-5029. This is a highly mobile system and is subject to change routes depending on highwater events. This stream has a braid that crosses the road near waypoint 1183 but reconnects at waypoint 1185 (Table 1; Figures 1–3).

Figure 2.—Braid crossing the road at waypoint 1183.

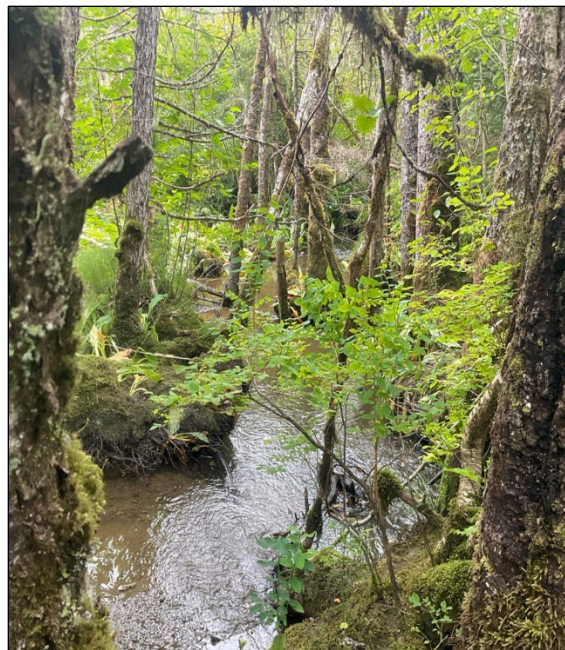
Figure 3.—Stream going south of the bridge at waypoint 1185.

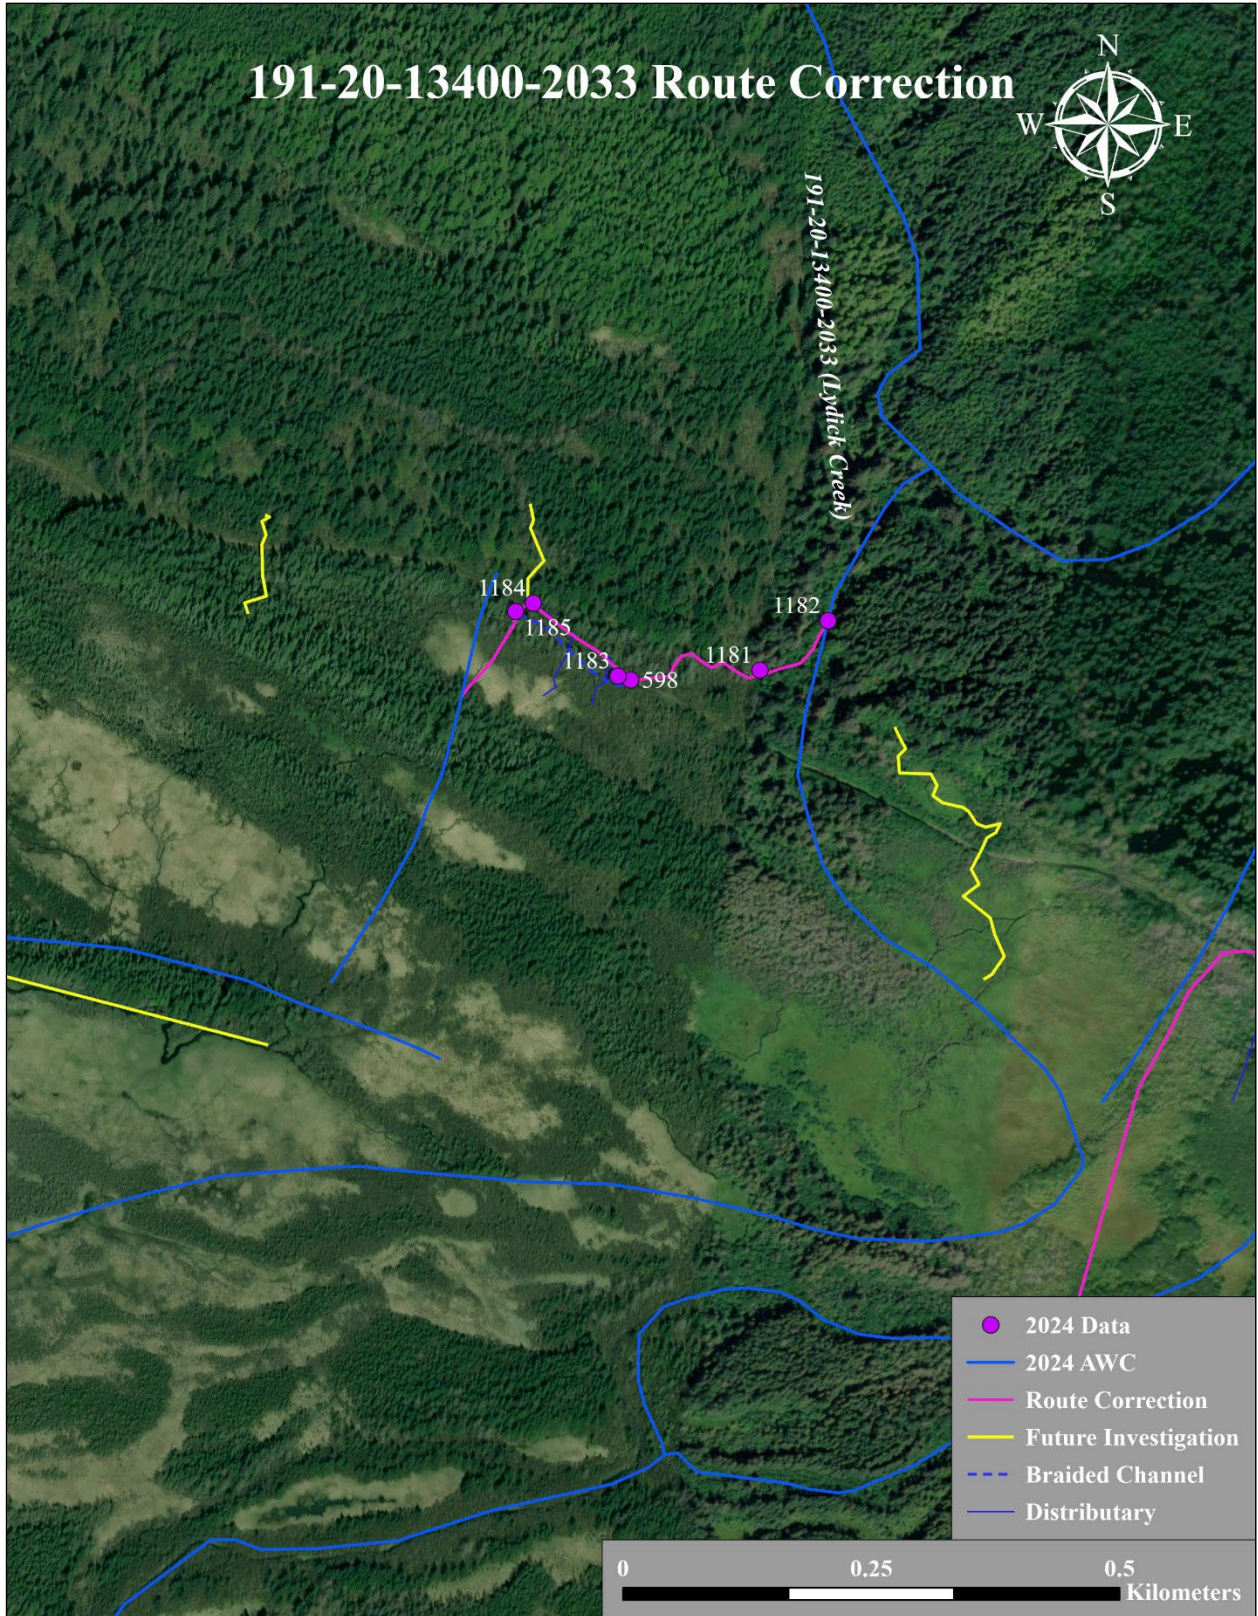
Figure 4.—191-20-13400-2033 route correction map.

Recommendations: Correct Stream No. 191-20-13400-2033 in the anadromous waters catalog to reflect the field verified stream path (Figure 4).
