# Alaska Department of Fish and Game

Habitat Section  
Southeast Region

## 191-20-13800 Tributary 2

**ADDITION**

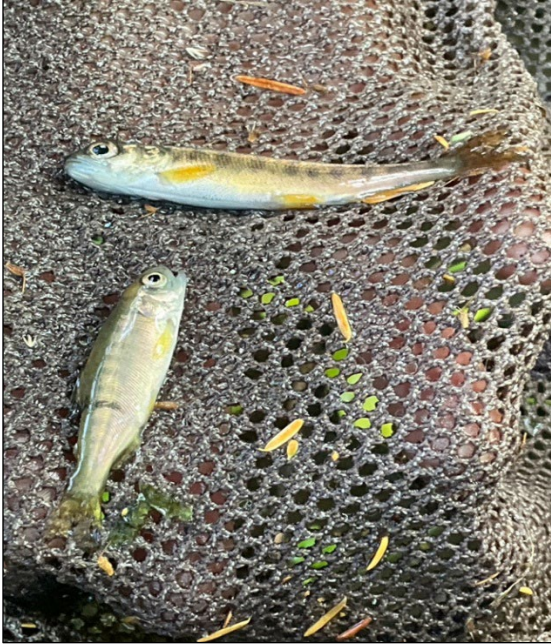
Figure 1.—Juvenile coho salmon caught just below the removed road crossing.

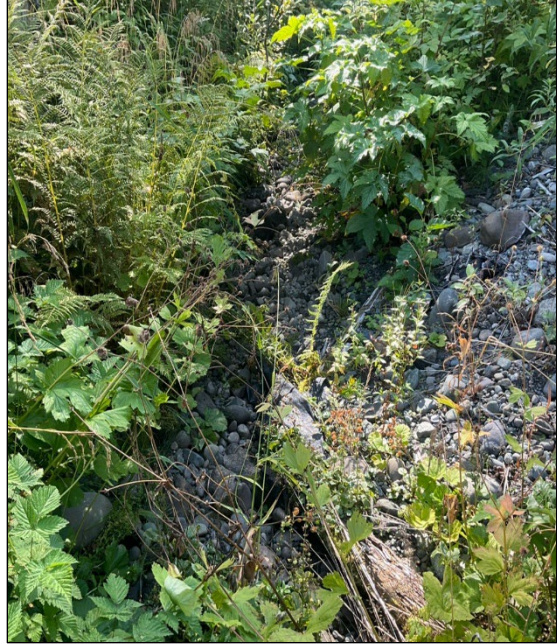
**Findings:** We surveyed this uncataloged stream using a backpack electrofisher and GPS and captured juvenile coho salmon. The stream meanders through a forested buffer. An old crossing structure was removed at waypoint 1152; lots of rocks and woody debris in channel where crossing structure was removed has caused this section to go dry or subsurface. Coho caught below the dry stretch but not above. The debris jam is likely blocking passage to fish habitat further upstream in the forested buffer, although water may connect during high flows (Table 1; Figures 1–4).

Figure 2.—Debris erosion and dry channel at waypoint 1152.

**Recommendations:** Add this uncataloged stream to the anadromous waters catalog for rearing coho salmon up to waypoint 1152 (Figure 5).

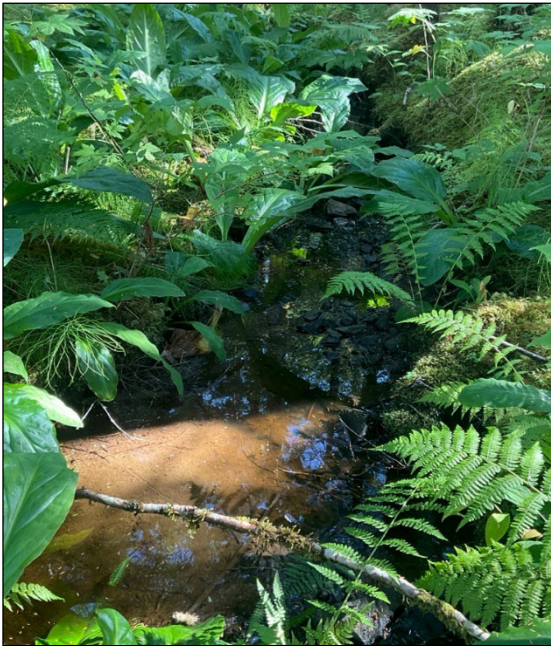
Figure 3.—Looking downstream at waypoint 1151.

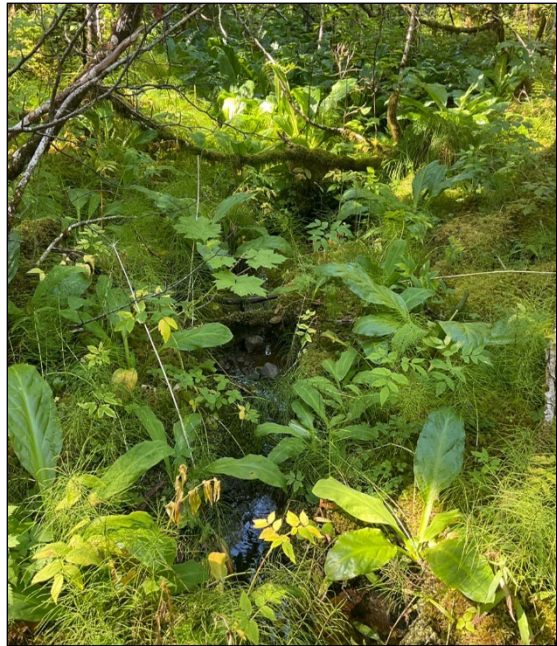
Figure 4.—Looking upstream at waypoint 1150.
