Alaska Department of Fish and Game

Habitat Section
Southeast Region

191-20-13800 Tributary 3

ADDITION

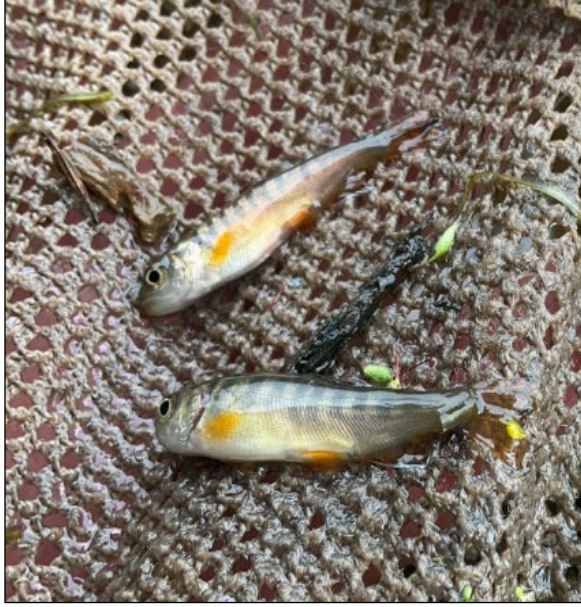
| Waypoint | Latitude | Longitude | Notes | Stream Width ft | Stream Substrate | Habitat Features | Gradient % | Sample Effort | Sample Results |
|---|---|---|---|---|---|---|---|---|---|
| 753 | 59.979092 | -141.643508 | Young of year coho capture. Woody debris throughout stream. | 2-4 | Fine Organic | | | | 2 CO |

Figure 1.—Juvenile coho salmon caught at waypoint 753.

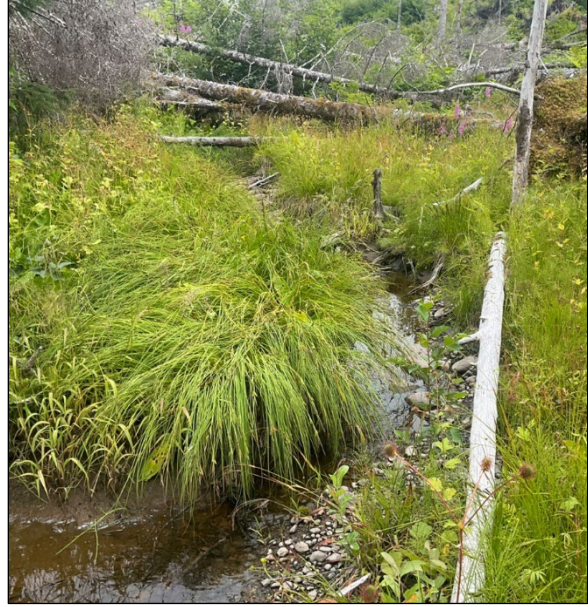
Figure 2.—Looking upstream at waypoint 753.

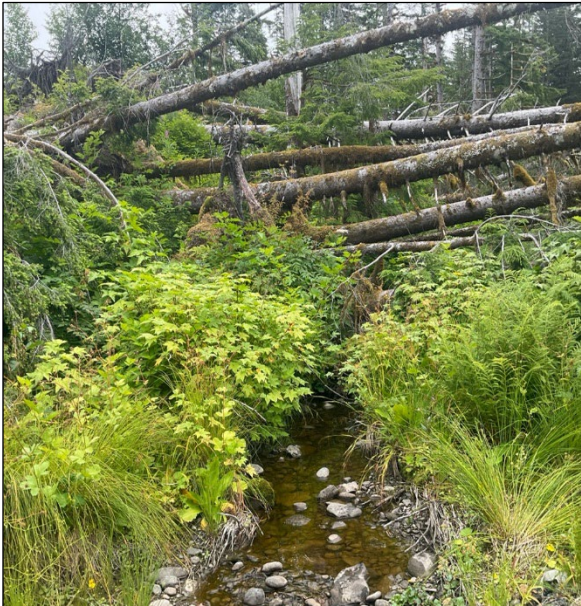
| Waypoint | Latitude | Longitude | Notes | Stream Width ft | Stream Substrate | Habitat Features | Gradient % | Sample Effort | Sample Results |
|---|---|---|---|---|---|---|---|---|---|
| 755 | 59.979013 | -141.642933 | Coho capture up to road crossing fish habitat likely continues for a while. Significant blowdown upstream of the road may limit further survey work. | | | | 1-2 | | 2 CO |

Figure 3.—Buffer blown into the stream channel at waypoint 755.

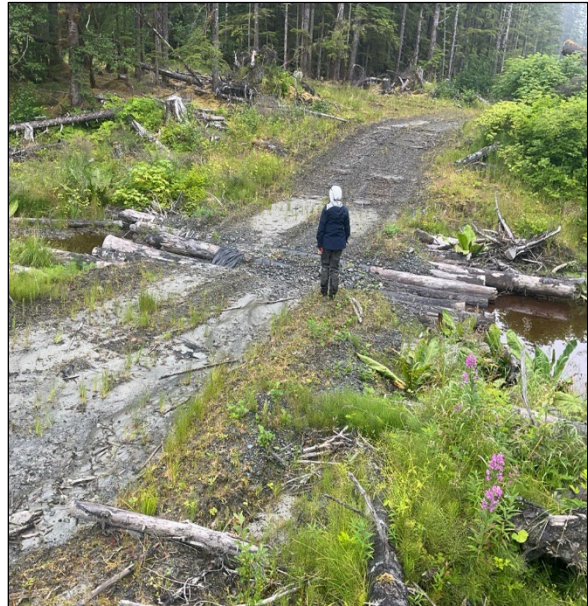
| Waypoint | Latitude | Longitude | Notes | Stream Width ft | Stream Substrate | Habitat Features | Gradient % | Sample Effort | Sample Results |
|---|---|---|---|---|---|---|---|---|---|
| 761 | 59.977462 | -141.639355 | Stream flows opposite of what's drawn. This is headwaters of stream to west. Log bridge not constructed, puncheon still here. Massive road erosion seen. Bunch of trees fell over the creek just downstream. Poor for fish passage and affecting the stream itself. Needs to be addressed. Lots of input material from roadbed. | | | | | VI | 2 CO |

Figure 4.—Puncheon bridge at waypoint 761.

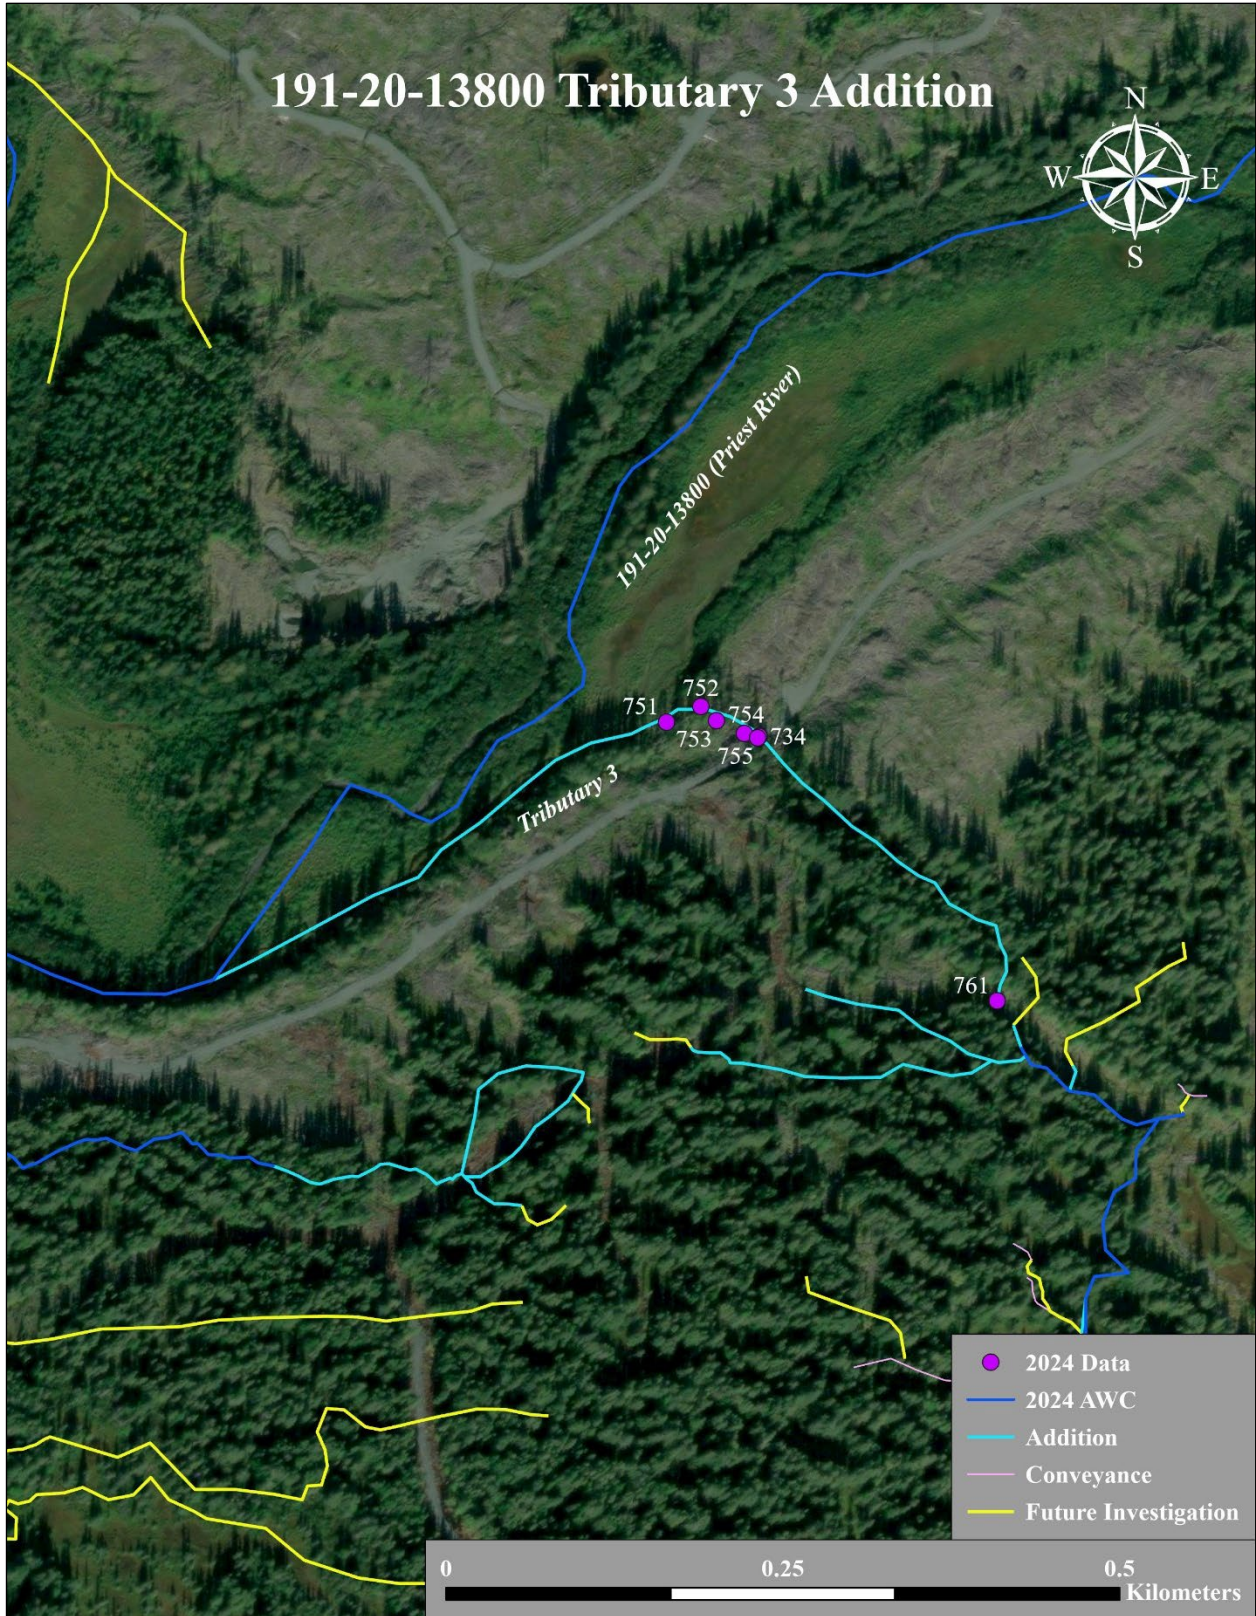
Figure 5.—191-20-13800 tributary 3 addition map.

Recommendations: Add this uncataloged stream to the anadromous waters catalog for rearing coho salmon up to waypoint 761 (Figure 5).
