Alaska Department of Fish and Game

Habitat Section
Southeast Region

115-32-10300-2002-3019-4005

ADDITION

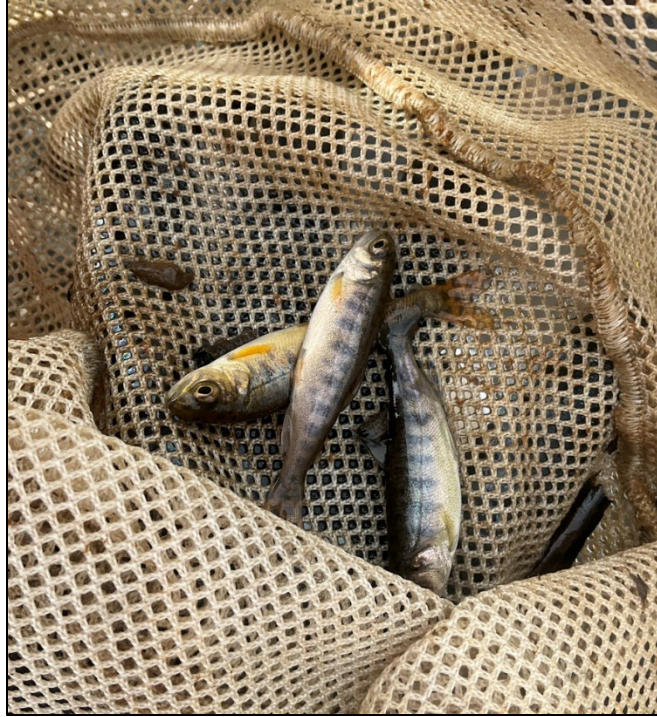
Figure 1.—Juvenile coho salmon caught at waypoint 1426.

Recommendations: Extend Stream No. 115-32-10300-2002-3019-4005 to waypoint 1426 in the anadromous waters catalog and add rearing coho salmon to species list (Figure 4).

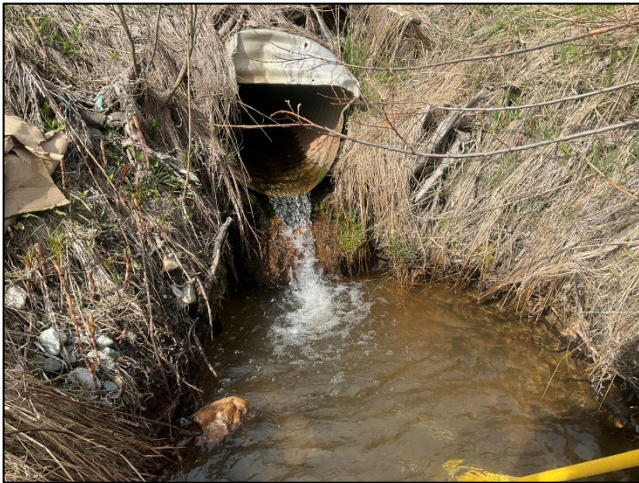
Findings: We surveyed this uncataloged stream from the road using a backpack electrofisher and GPS and captured juvenile coho salmon and cutthroat trout. The stream flows slowly along the roadside in a ditch. At waypoint 1425, the stream flows through a 164ft long culvert at 4.5% grade and is perched 1ft at the outlet. Coho caught upstream of the pipe indicates the pipe is passable under certain flow conditions. Upstream of the pipe, stream has a defined channel with small gravel and fine sediment substrate. (Table 1; Figures 1–3).

Figure 2.—Perched culvert at waypoint 1425.

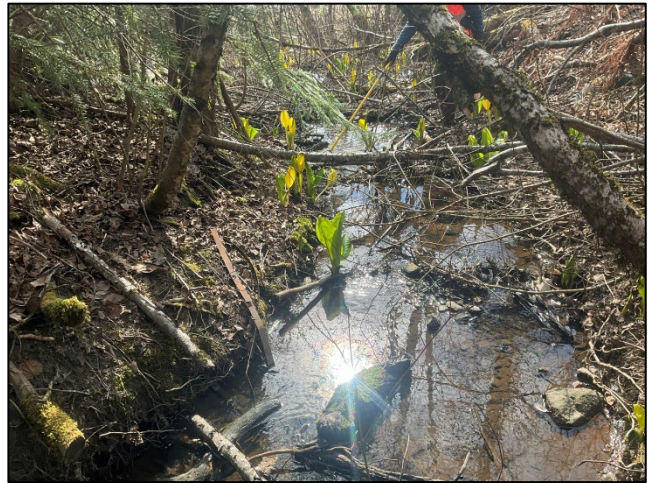
1427	59.238797	-135.45646	Corrugated plastic pipe draining ponded area. 8in trout in plunge pool. Pipe set at more than 20% grade.					EF	1 CT

Figure 3.—Channel at waypoint 1427.
