Alaska Department of Fish and Game

Habitat Section
Southeast Region

107-30-10760 Tributary 1

ADDITION

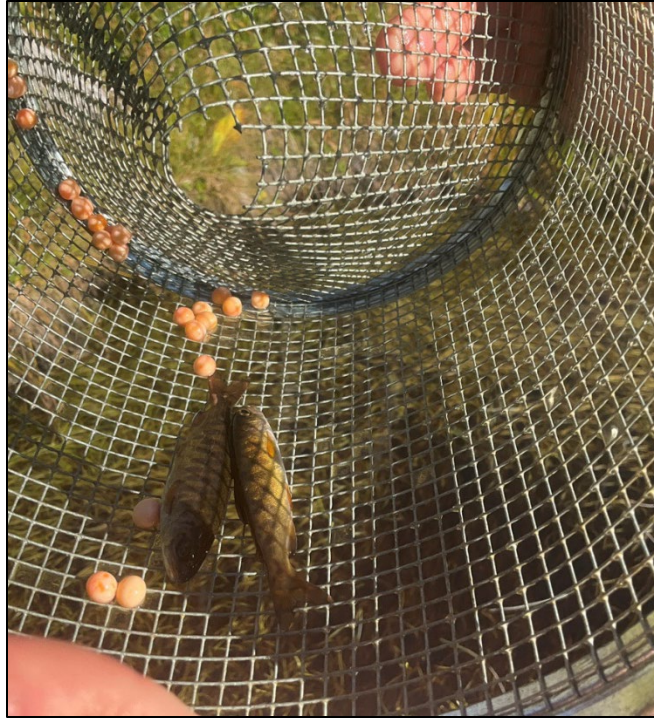
Figure 1.—Juvenile coho salmon caught at waypoint 1001.

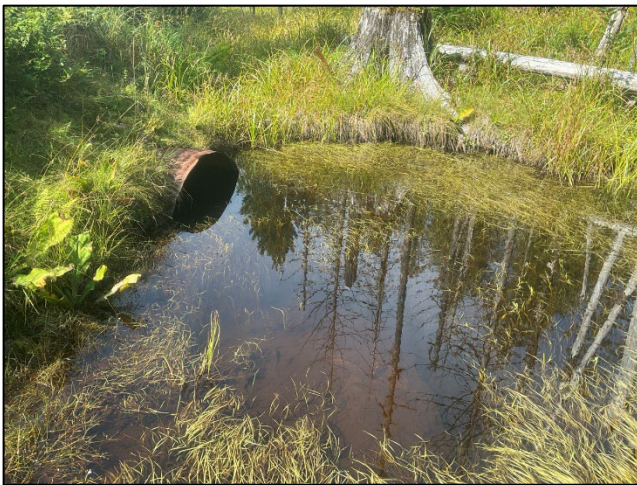
Findings: We surveyed this uncataloged stream from the road using baited minnow traps and GPS and captured juvenile coho salmon, Dolly Varden, and cutthroat trout. The stream is characterized by mostly stagnant water due to beaver dams in the area. The stream crosses the road via a 3 ft corrugated metal culvert that is fully backwatered. Immediately upstream of the pipe is a 3.5 ft beaver dam that appears to be blocking fish passage; only resident fish caught above this dam (Table 1; Figures 1–3). We used the US Forest Service stream layer to depict the channel downstream.

Figure 2.—Backwatered inlet of culvert at waypoint 1001.

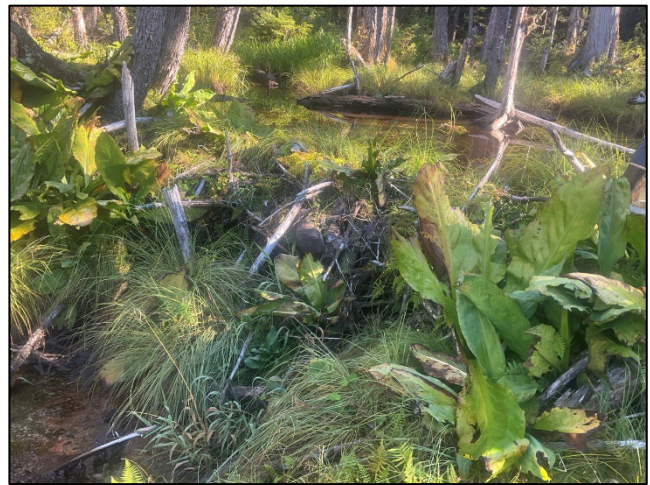
Figure 3.—Beaver dam at waypoint 1038.
