# Alaska Department of Fish and Game

## Anita Bay Uncataloged Stream

## ADDITION

**Water body name:** Beaver Creek

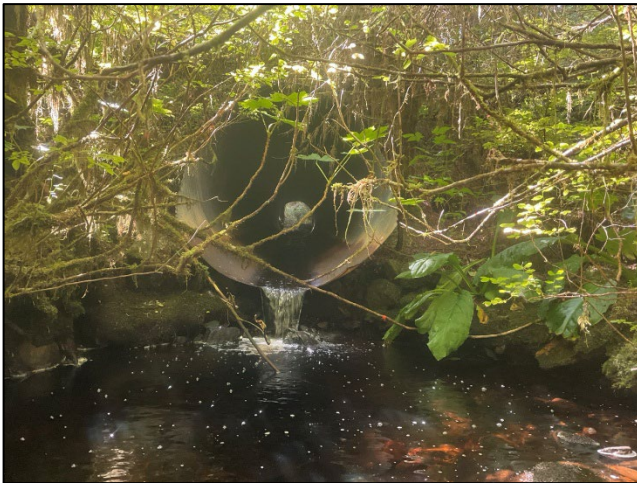
**Findings:** We surveyed this uncataloged stream from the road using baited minnow traps, a backpack electrofisher and GPS and captured juvenile coho salmon, Dolly Varden, and cutthroat trout. This stream crosses the road at waypoint 1000 via a 6ft metal corrugated culvert that is perched 1ft at the outlet. Riprap has fallen into the stream at the inlet of the pipe blocking normal stream flow and likely fish passage as well. No anadromous fish were caught above the pipe. Upstream from the pipe, the stream flows at a moderate gradient around 4% with abundant spawning substrate and quality rearing habitat. Downstream of the pipe, the stream has predominantly cobble and boulder substrate before flowing into the intertidal. (Table 1; Figures 1–3)

Figure 2.—Perched culvert at waypoint 1000.

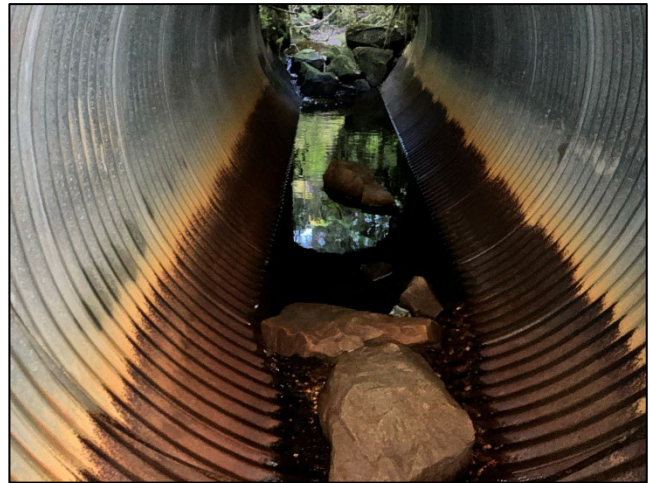
Figure 3.—Inlet of culvert with fallen rip rap blocking the channel and fish passage at waypoint 1000.
