# Alaska Department of Fish and Game

## 106-22-10080 Tributary 5

## ADDITION

**Water body name:** Sophie's Stream

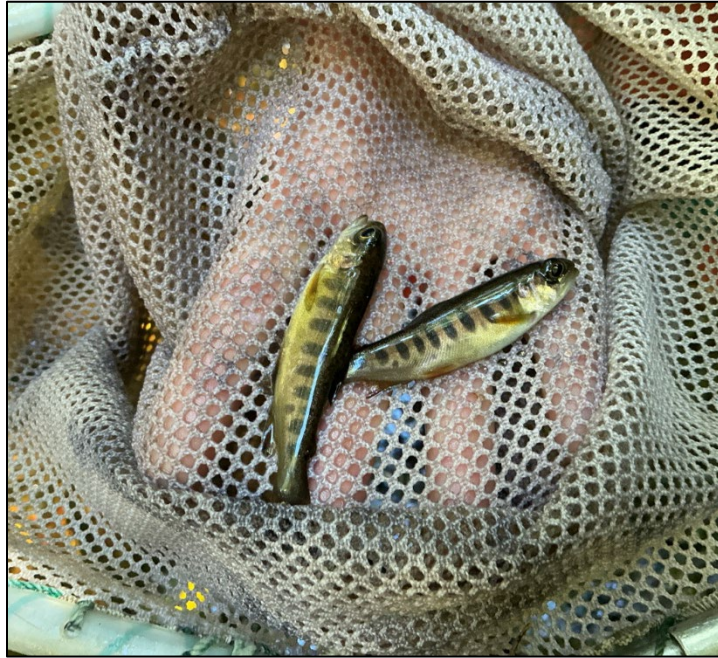
Figure 1.—Juvenile coho salmon caught at waypoint 1034.

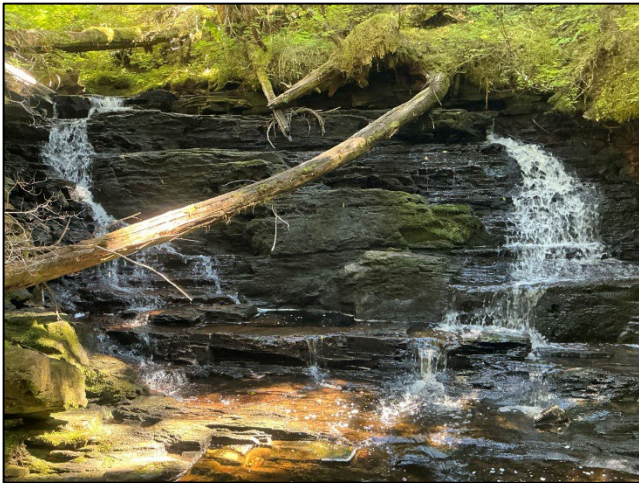
**Findings:** We surveyed this uncataloged stream up to an anadromous fish barrier using a backpack electrofisher, baited minnow traps and GPS and captured juvenile coho salmon, Dolly Varden and cutthroat trout. We also visually identified adult pink salmon spawning throughout the stream. At its lower reaches, this stream flows at a mild 1–2% gradient with predominantly large and small gravel substrate providing quality spawning and rearing habitat. At waypoint 1034, the channel becomes highly incised with mostly bedrock substrate and increases grade to 5%. At waypoint 1035, we identified a bedrock water fall with water cascading nearly vertical for 30 ft with no jump pool at the base. This is likely blocking any anadromous fish passage upstream, even in higher flows. (Table 1; Figures 1–3)

Figure 2.—Bedrock falls identified as barrier to fish passage at waypoint 1035.

**Recommendations:** Add this uncataloged stream to the anadromous waters catalog up to waypoint 1034 for rearing coho salmon and spawning pink salmon and add a barrier point at waypoint 1035 (Figure 4).

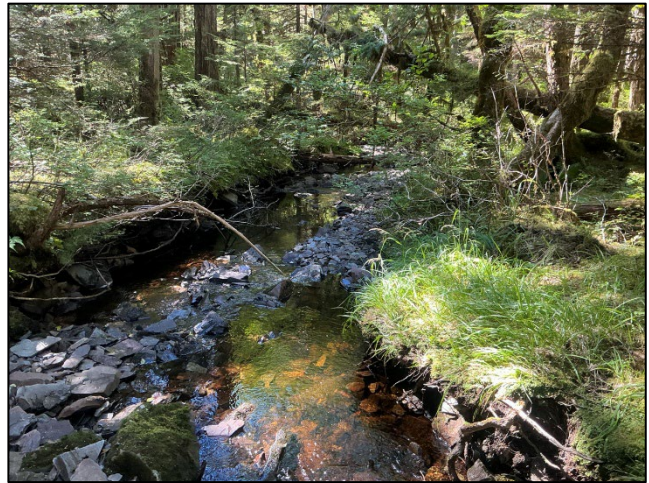
Figure 3.—Channel at waypoint 1033.
