# Alaska Department of Fish and Game

## 106-22-10080 Tributary 6

## ADDITION

**Water body name:** Marin Creek

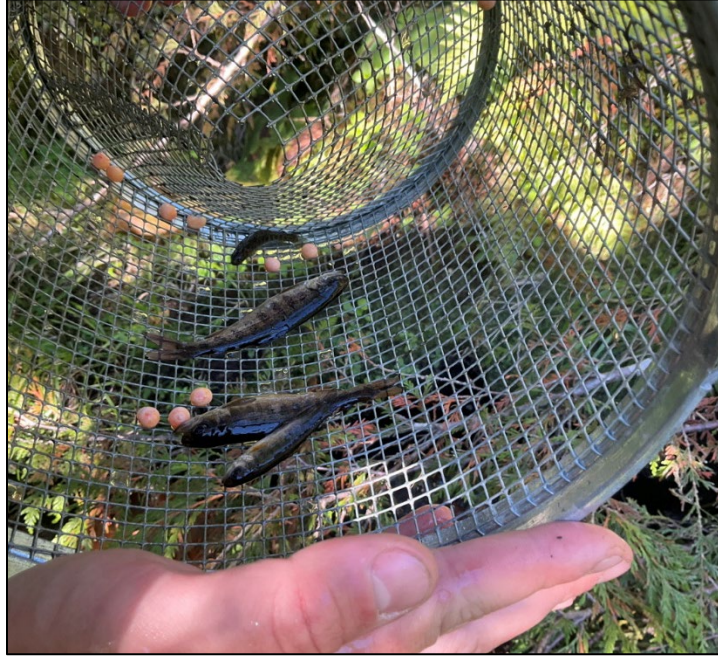
Figure 1.—Juvenile coho salmon and Dolly Varden caught at waypoint 1007.

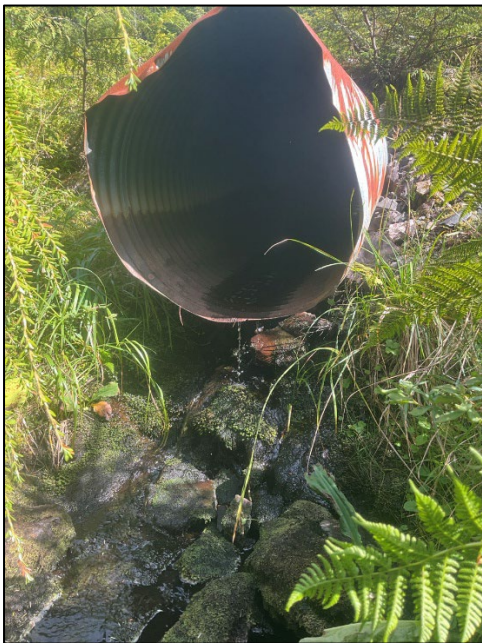
**Findings:** We surveyed this uncataloged stream from the road using a backpack electrofisher, baited minnow traps and GPS and captured juvenile coho salmon and Dolly Varden. This stream crosses the road via an old 48 inch rusted-out corrugated metal culvert that is perched 1.5 ft at the outlet. Juvenile coho salmon were caught above the pipe though, so it must not be a barrier to fish at all flows. Downstream of the pipe, the stream is shallow with mostly cobble substrate and flows through an area of clear cut. Upstream of the pipe, the stream narrows and becomes incised with mossy cut banks and flows subsurface in sections (Table 1; Figures 1–3).

Figure 2.—Perched culvert at waypoint 1007.

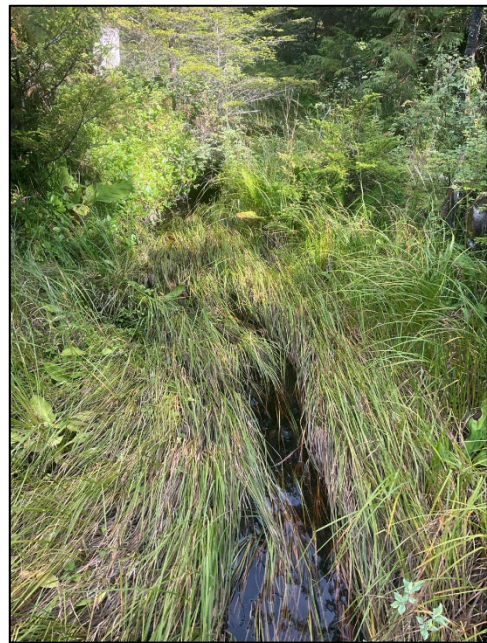
Figure 3.—Channel upstream of road crossing at waypoint 1026.
