Alaska Department of Fish and Game

106-22-10080 Tributary 7

ADDITION

Water body name: Weaver Brook

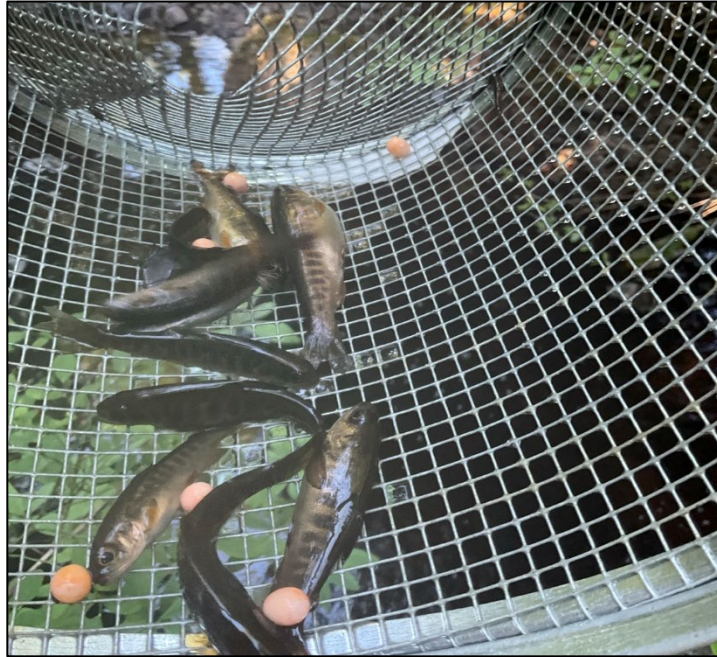
Figure 1.—Juvenile coho salmon and Dolly Varden caught at waypoint 1008.

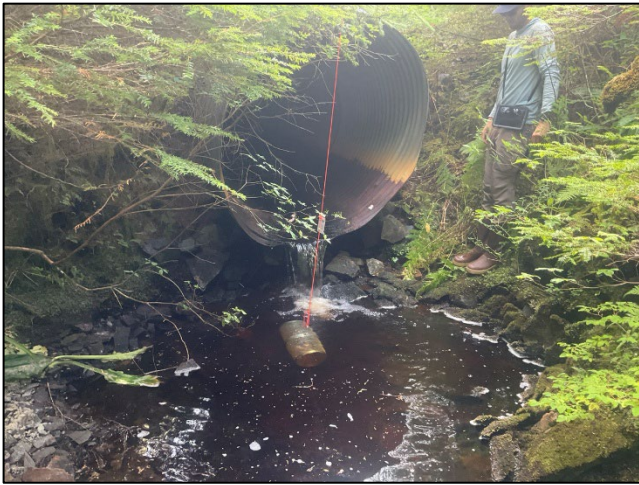
Findings: We surveyed this uncataloged stream from the road using a backpack electrofisher, baited minnow traps and GPS and captured juvenile coho salmon and Dolly Varden. This stream crosses the road via a 5 ft corrugated metal culvert that is perched 1.5 ft at the outlet. The pipe has minimal flow without any fill material inside and is likely a barrier to fish passage.

Figure 2.—Channel flowing through perched culvert at 1008.

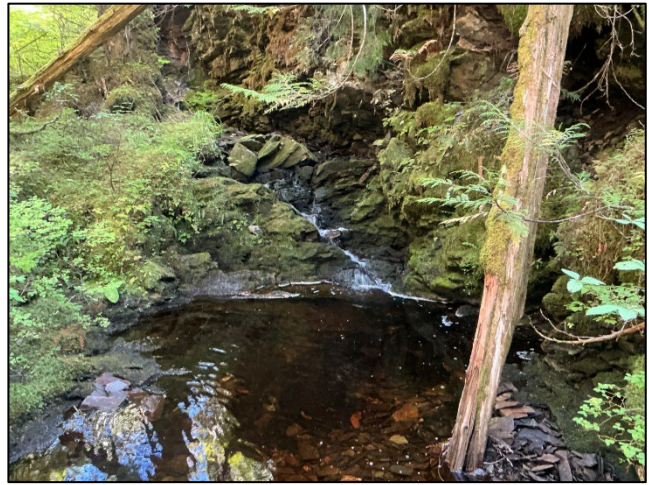
Downstream of the culvert, the stream has large gravel and cobble substrate and provides quality juvenile fish rearing habitat with woody debris and side pools throughout. About 100 ft upstream of the road crossing, there's a bedrock cascade that is also likely a barrier to fish passage. Only resident fish caught upstream of the perched culvert (Table 1; Figures 1–3).

Figure 3.—Bedrock cascade at waypoint 1031.

Recommendations: Add this uncataloged stream to the anadromous waters catalog up to waypoint 1008 for rearing coho salmon and add a barrier point at waypoint 1031 (Figure 4).
