Alaska Department of Fish and Game

Habitat Section
Southeast Region

114-32-10240 Tributary 1

ADDITION

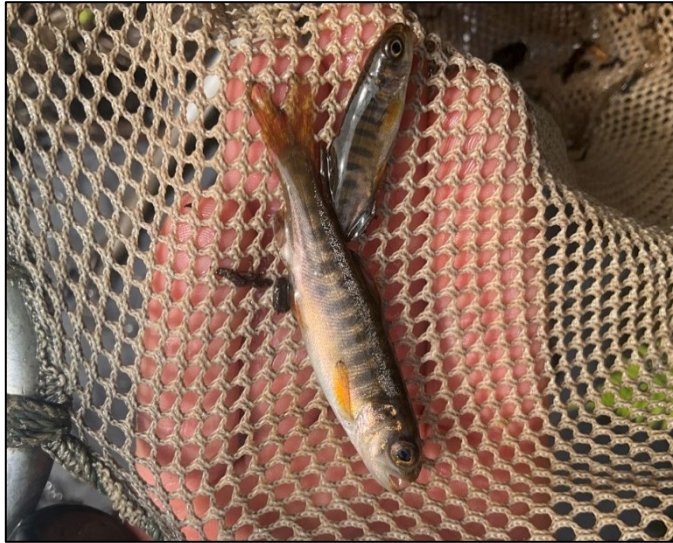
Figure 1.—Juvenile coho salmon captured at waypoint 362.

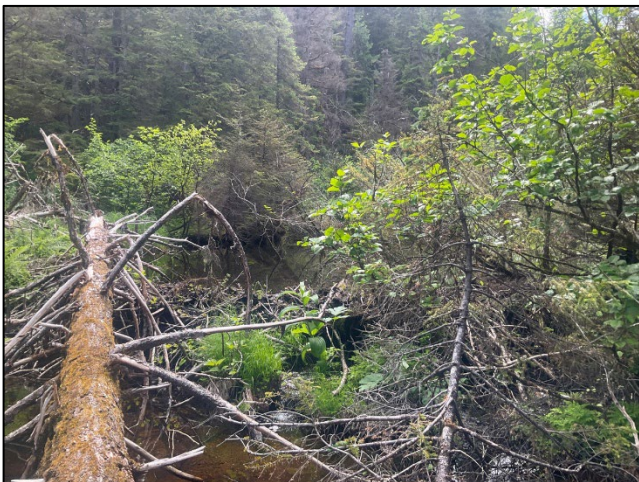
Findings: We surveyed this uncataloged stream using a backpack electrofisher and GPS and captured juvenile coho salmon. The main channel is broken up by a series of beaver dams and large woody debris. Survey ended due to time but this beaver dam complex continues upstream (Table 1; Figures 1–3).

Figure 2.—Beaver dam at waypoint 362.

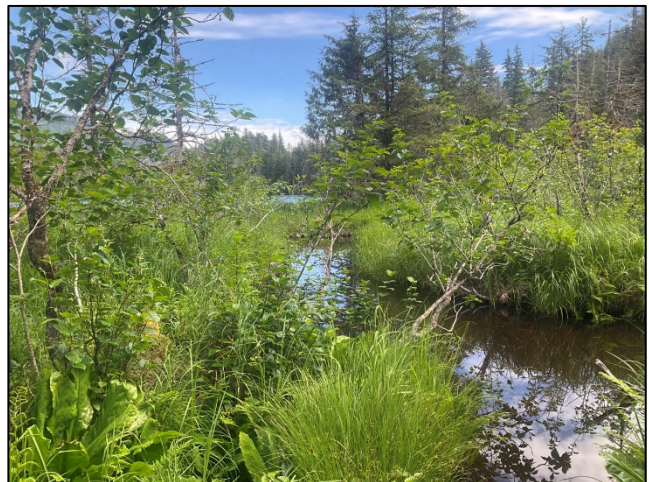
Figure 3.—Channel below beaver dam at waypoint 361.
