# Alaska Department of Fish and Game

Habitat Section  
Southeast Region

## 114-23-10700-2005 Tributary 3

## ADDITION

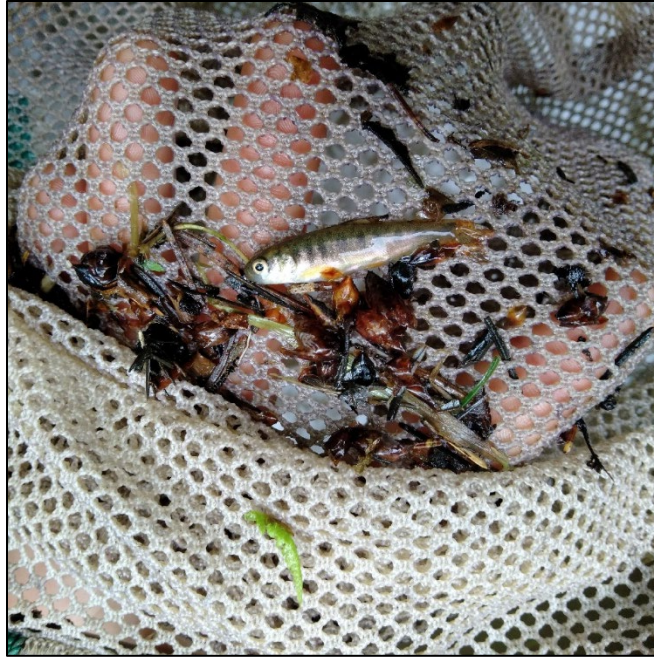
Figure 1.–Juvenile coho salmon captured at waypoint 479.

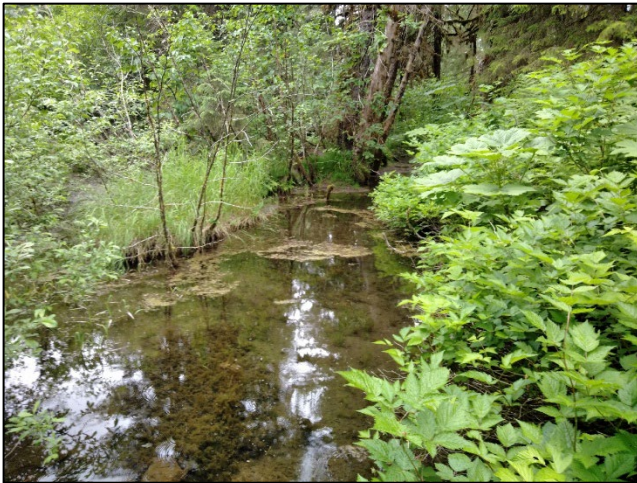
Figure 2.– Channel at waypoint 479.

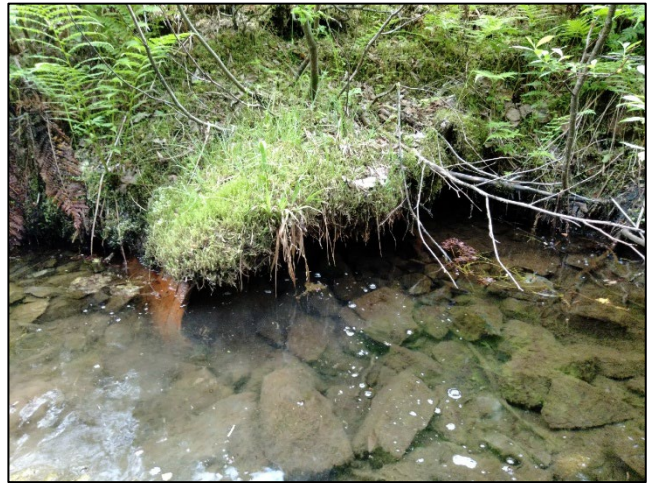
**Findings:** We surveyed this uncataloged stream from the road using a backpack electrofisher and GPS and captured juvenile coho salmon and cutthroat trout. Two stream channels converge at the culvert inlet resulting in the backwatering of the pipe. The culvert here has substantial rust and is squashed due to the weight of the roadbed but doesn't appear to be blocking fish passage. Good fish habitat appears to continue upstream, warranting future investigation. (Table 1; Figures 1–3)

Figure 3.– Outlet of culvert at waypoint 479.

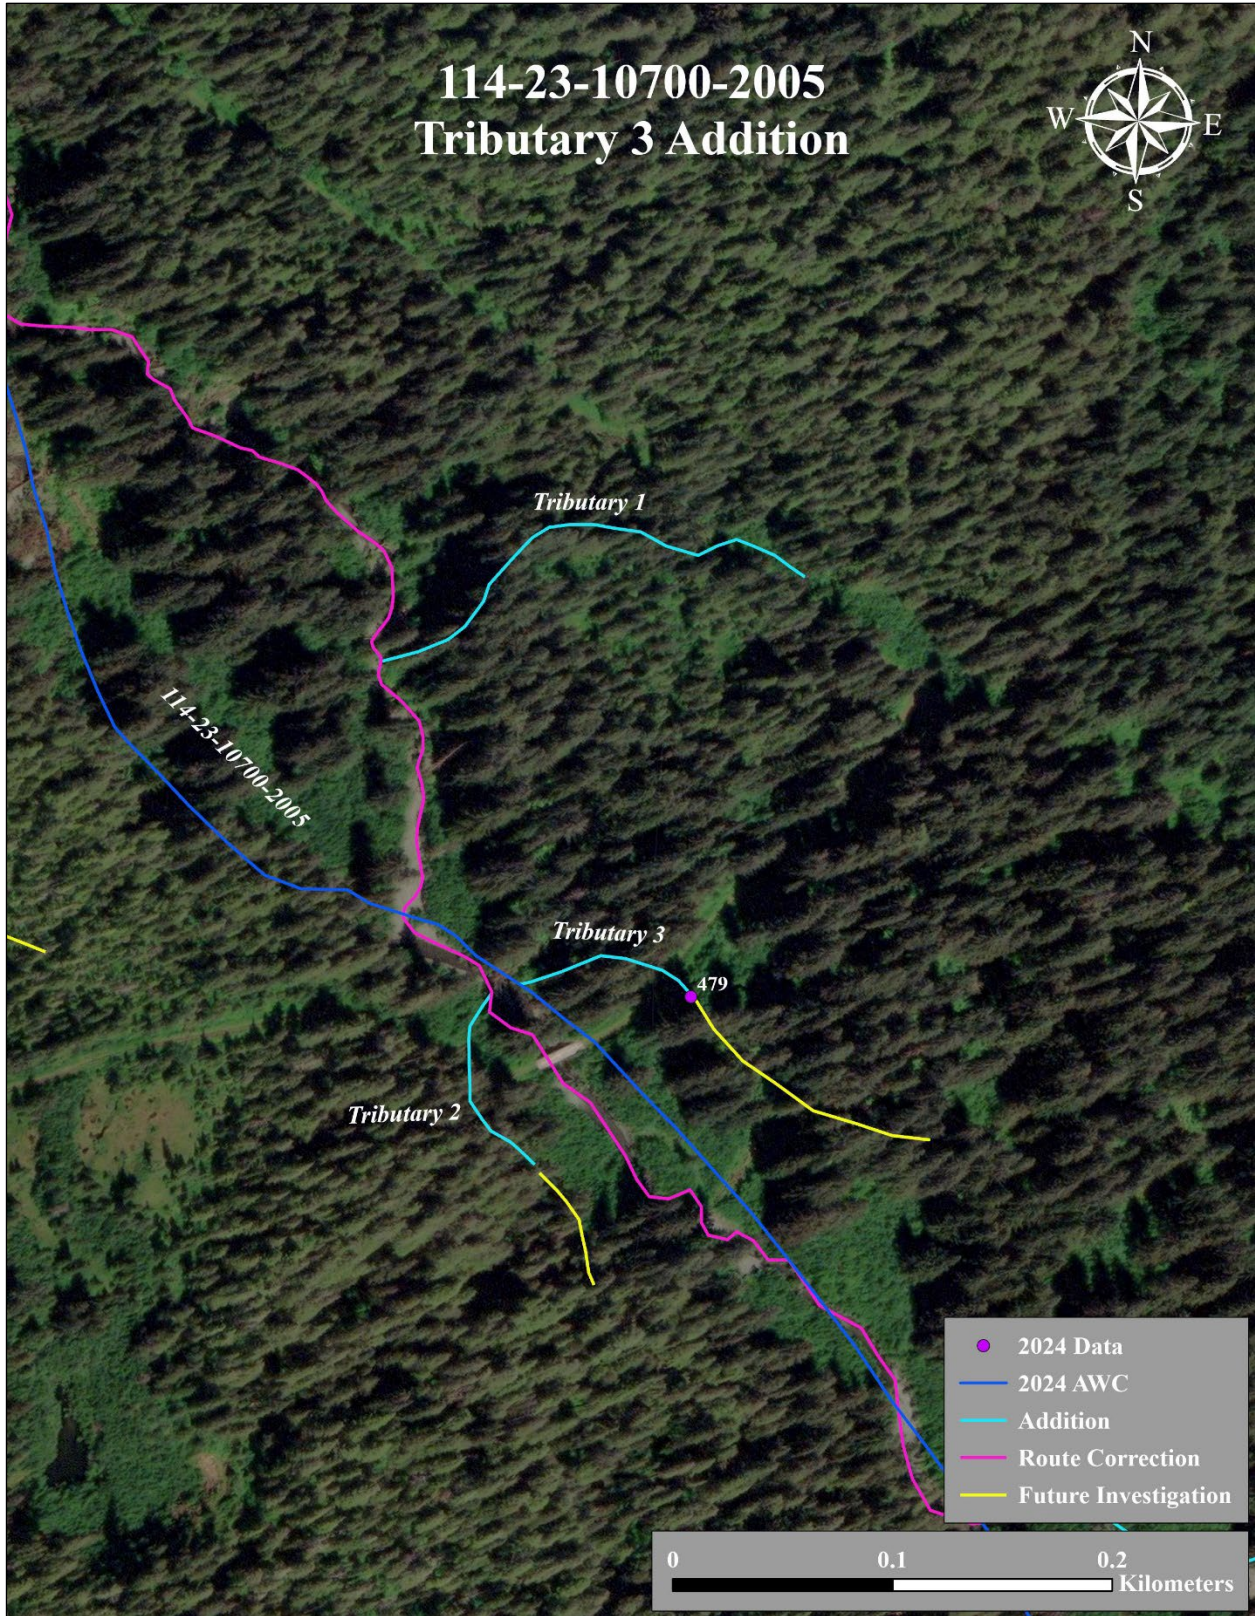
Figure 4.—Stream No. 114-23-10700-2005 Tributary 3 addition.

**Recommendations:** Add this stream into the anadromous waters catalog for rearing coho salmon. (Figure 4).
