Alaska Department of Fish and Game

186-15-10550

Water body name: Carson Creek

Survey date: 7/18/2024

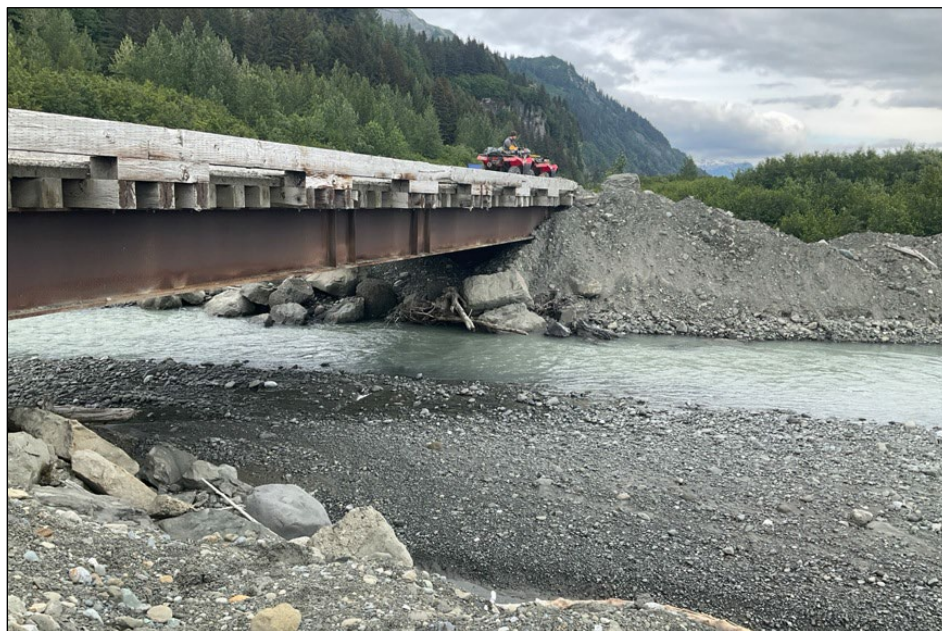
Waypoint	Latitude	Longitude	Notes	Stream Width ft	Stream Substrate	Habitat Features	Gradient %	Sample Effort	Sample Results
612	59.987632	-141.518523	Main channel has been directed under bridge. Upstream has berm piles to help direct it. Bridge itself is in decent shape but erosion looks like a constant issue for abutments. Large boulders help stabilize but evidence of erosion during higher flows.

Figure 1.–East abutment of Carson Creek bridge.

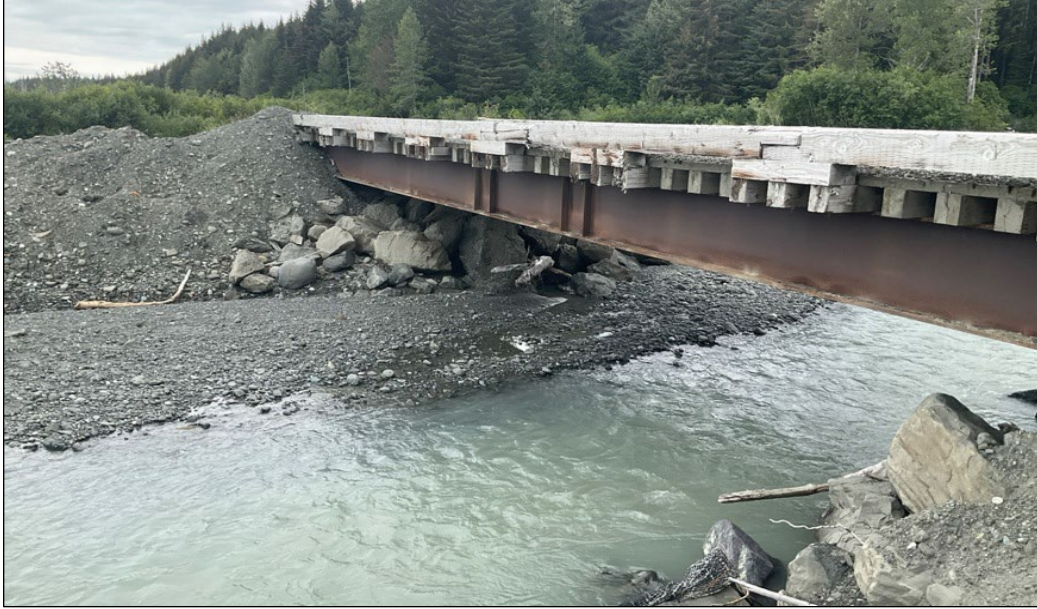
Figure 2.—West abutment of Carson Creek bridge.

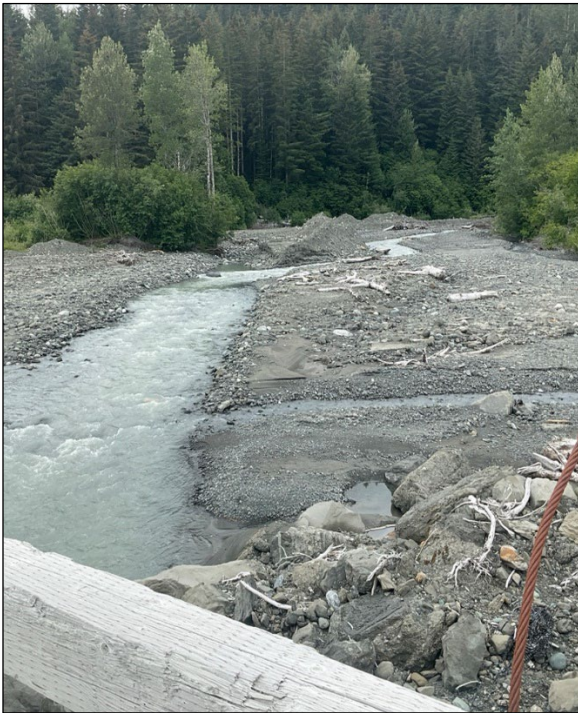
Findings: We surveyed this cataloged stream with a backpack electrofisher and GPS and found that the stream path is incorrectly mapped. The main flow was directed under the bridge with the help of berm piles; flow continues downstream to the intertidal beach (Table 1; Figures 1–4).

Figure 3.—Berm piles upstream of Carson Creek bridge.

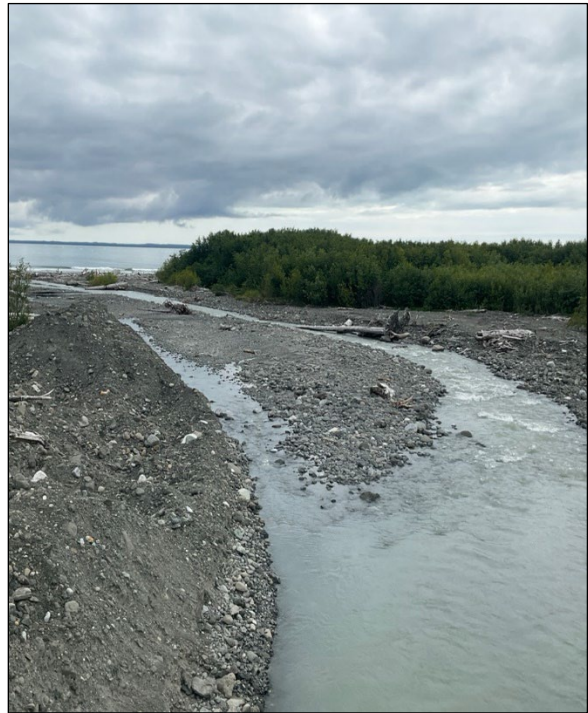
Figure 4.—Downstream, looking towards the intertidal beach.

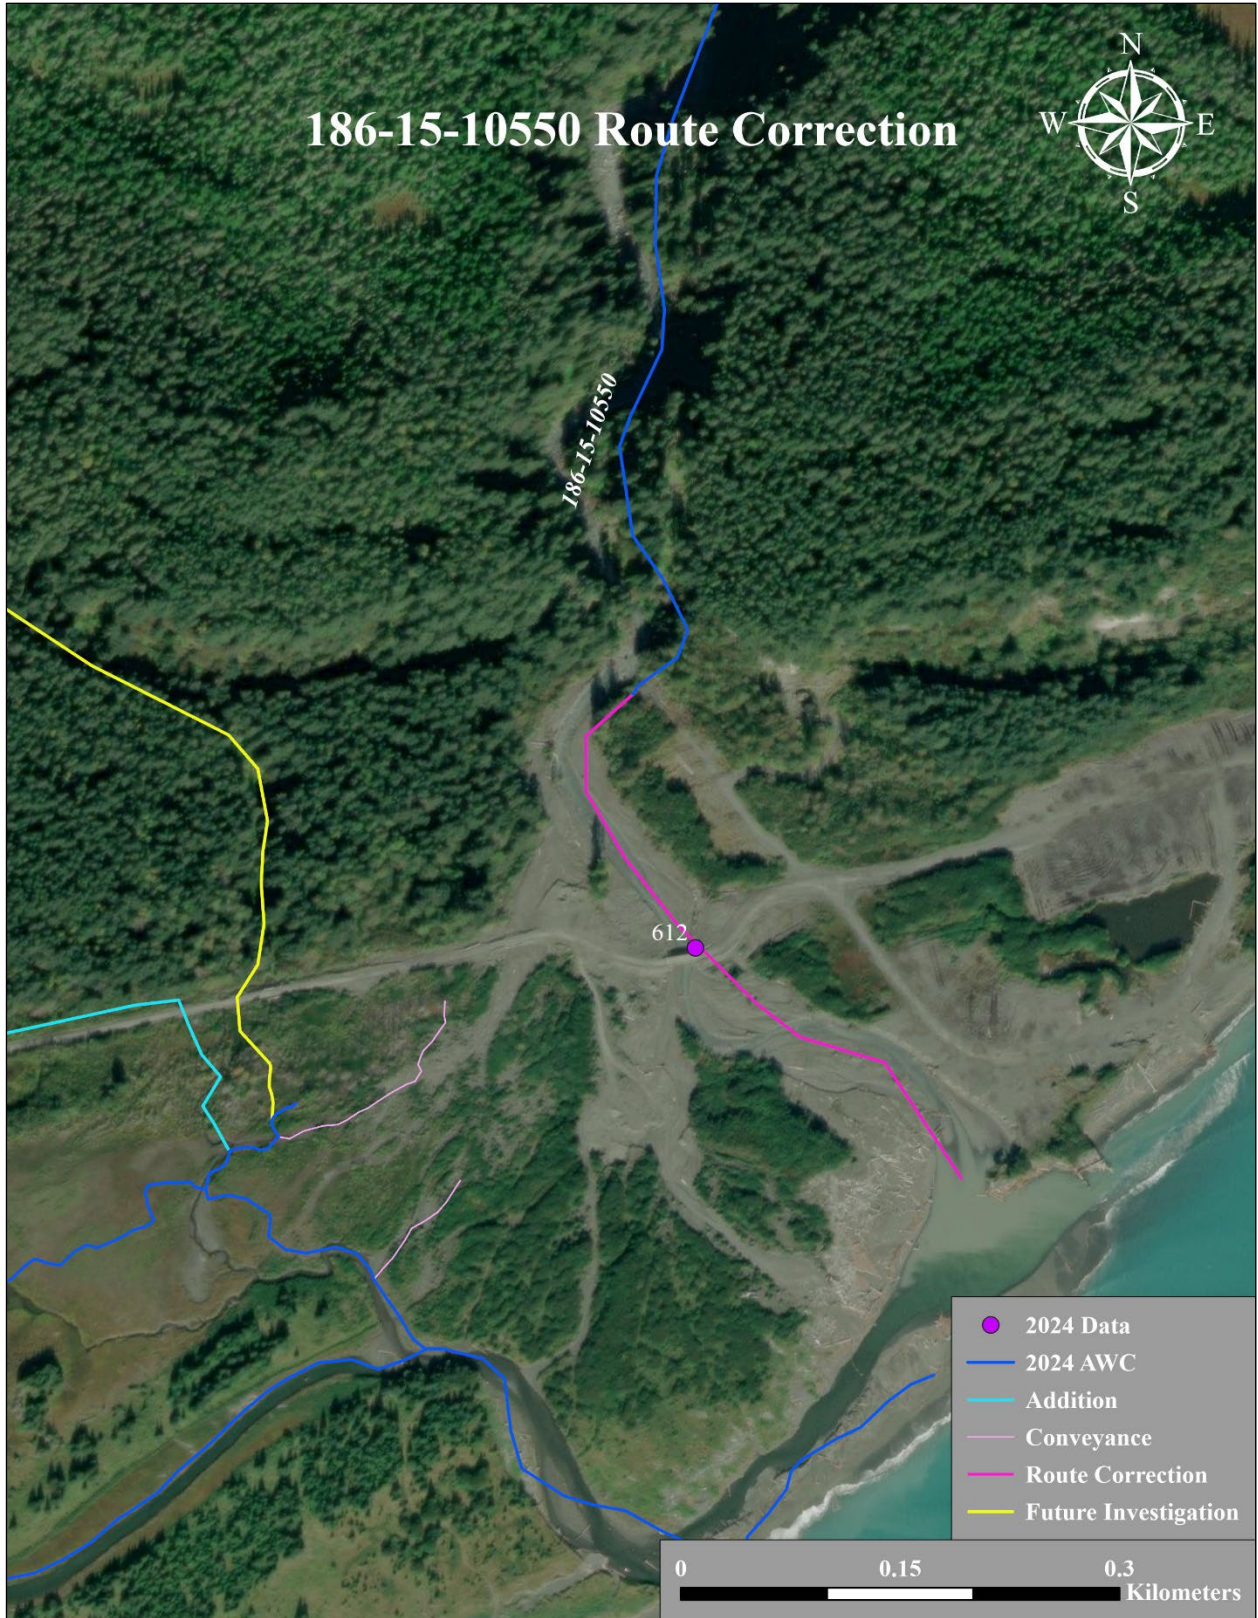
Figure 5.—186-15-10550 route correction map.

Recommendations: Correct Stream No. 186-15-10550 in the anadromous waters catalog to reflect the field verified stream path and extend stream into the intertidal (Figure 5).
