Alaska Department of Fish and Game

191-20-13400

CORRECTION

Water body name: Big Sandy Creek

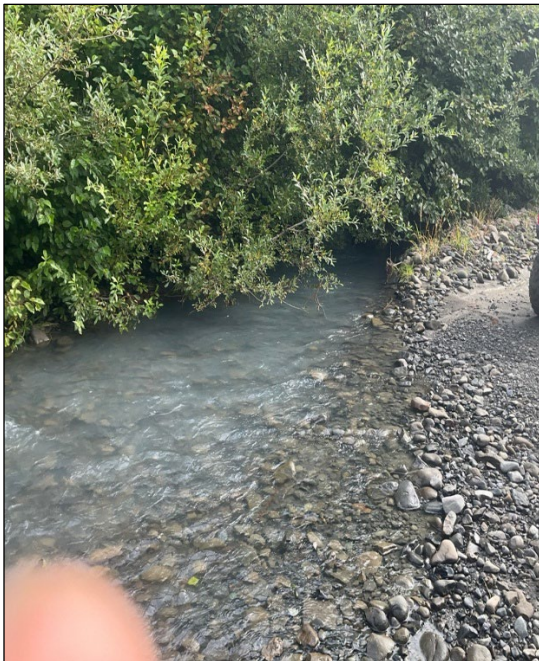
Waypoint	Latitude	Longitude	Notes	Stream Width ft	Stream Substrate	Habitat Features	Gradient %	Sample Effort	Sample Results
1180	59.994533	-141.763950	Main flow parallels road where the distributary line is currently showing, needs to be route corrected. During high water as seen earlier, main flow will jump the berm and flow down the road.	10-12	Cobble Large Gravel		4-6

Figure 1.–Stream paralleling the road, looking upstream at waypoint 1180.

Recommendations: Correct Stream No. 191-20-13400 in the anadromous waters catalog to reflect the field verified stream path (Figure 3).

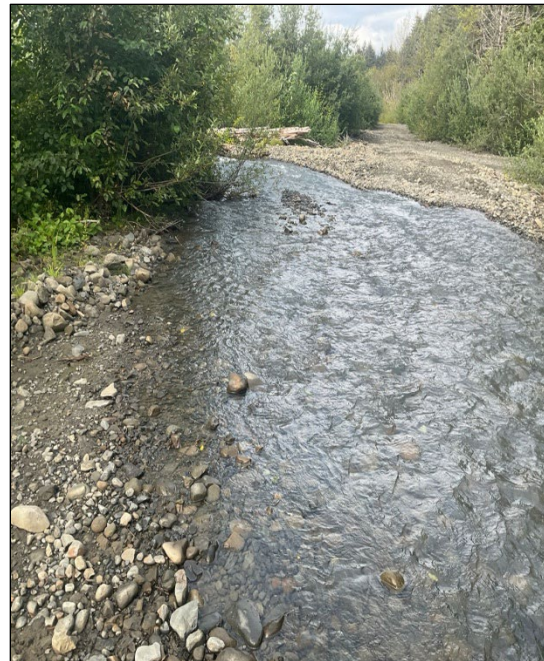
Findings: We surveyed this cataloged stream using a backpack electrofisher and GPS and found that the stream path is incorrectly mapped. The main flow of this stream parallels the road running north west, then jumps the road and heads south. This is a highly mobile area so it likely changes depending on high water events. The exact route south of the road is unclear but drawn based on topography (Table 1; Figures 1, 2).

Figure 2.–Stream crossing the road at waypoint 1180.
