# Alaska Department of Fish and Game

Habitat Section  
Southeast Region

**191-20-13400-2033-3005-4035**

**ADDITION**

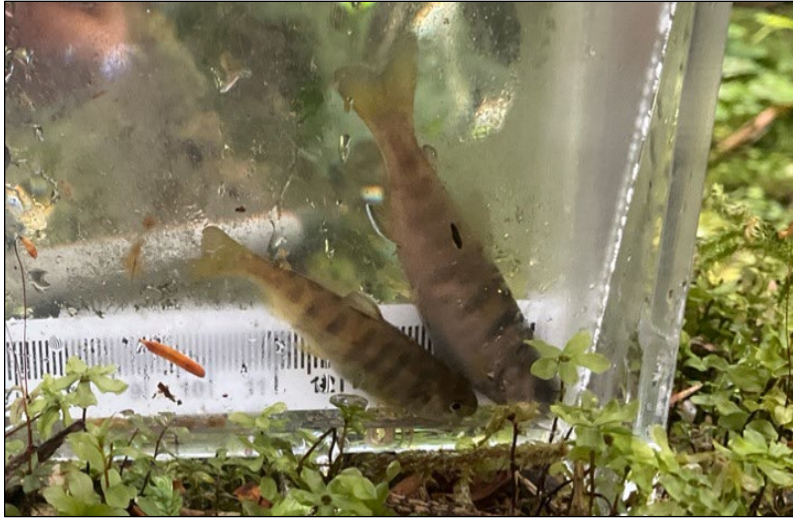
Figure 1.–Juvenile coho salmon caught at waypoint 626.

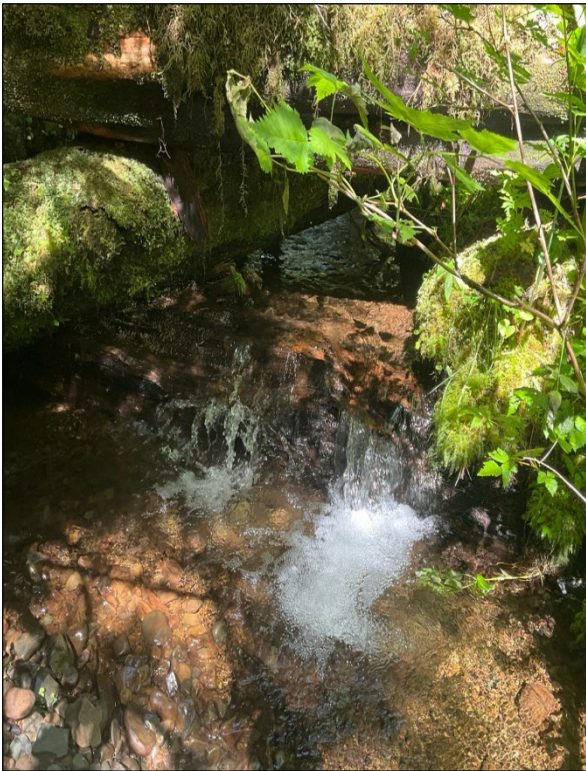
Figure 2.–Small waterfall, looking upstream at waypoint 627.

**Recommendations:** Correct Stream No. 191-20-13400-2033-3005-4035 to reflect the field verified stream path and extend the upper extent in the anadromous waters catalog for rearing coho salmon up to waypoint 627 (Figure 4).

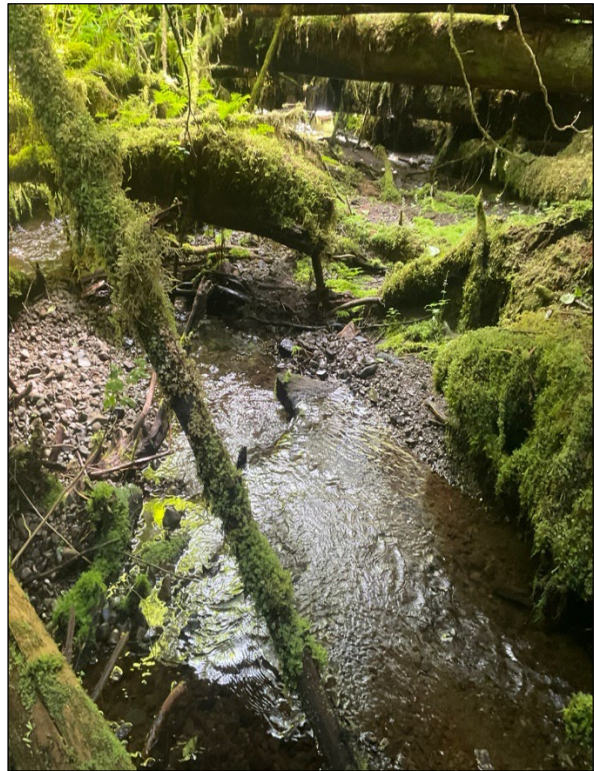
**Findings:** We surveyed this stream using a backpack electrofisher and GPS and captured juvenile coho salmon. This stream needs to be route corrected from its confluence with Stream No. 191-20-13400-2033-3005 (Lydick Creek). Channel is incised in some locations from previous logging activities and is approximately 10 ft wide with gravels, pools, and large woody debris spanning the channel. Survey ended due to time but fish habitat likely continues (Table 1; Figures 1–3).

Figure 3.–Channel at waypoint 625, looking downstream.
