# Alaska Department of Fish and Game

Habitat Section  
Southeast Region

## 182-70-11600 Tributary 1

**Survey date:** 9/14/2024

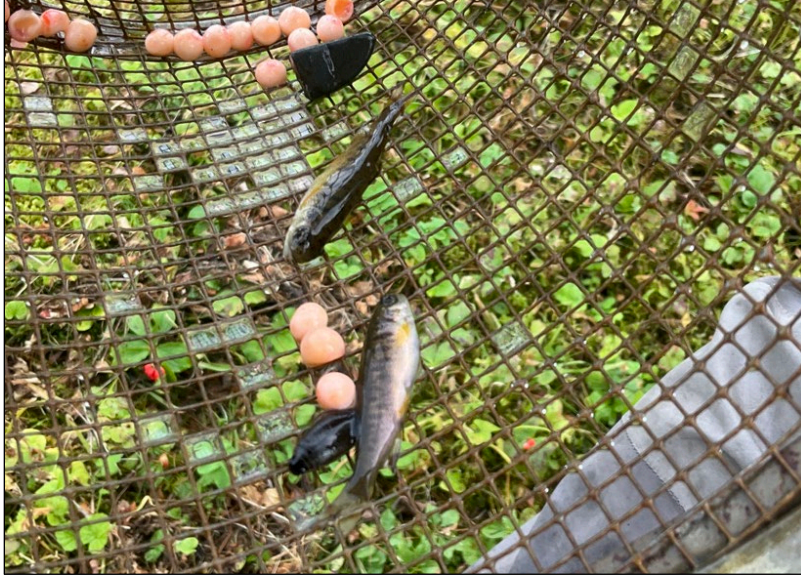
**Findings:** We surveyed this uncataloged stream from the road using baited minnow traps and GPS and captured juvenile coho salmon (Figure 1). The stream is low gradient but the culvert appears to be undersized for the stream channel (Table 1; Figures 2, 3). A culvert survey and future investigation upstream is recommended.

Figure 1.—Juvenile coho salmon at waypoint 1231.

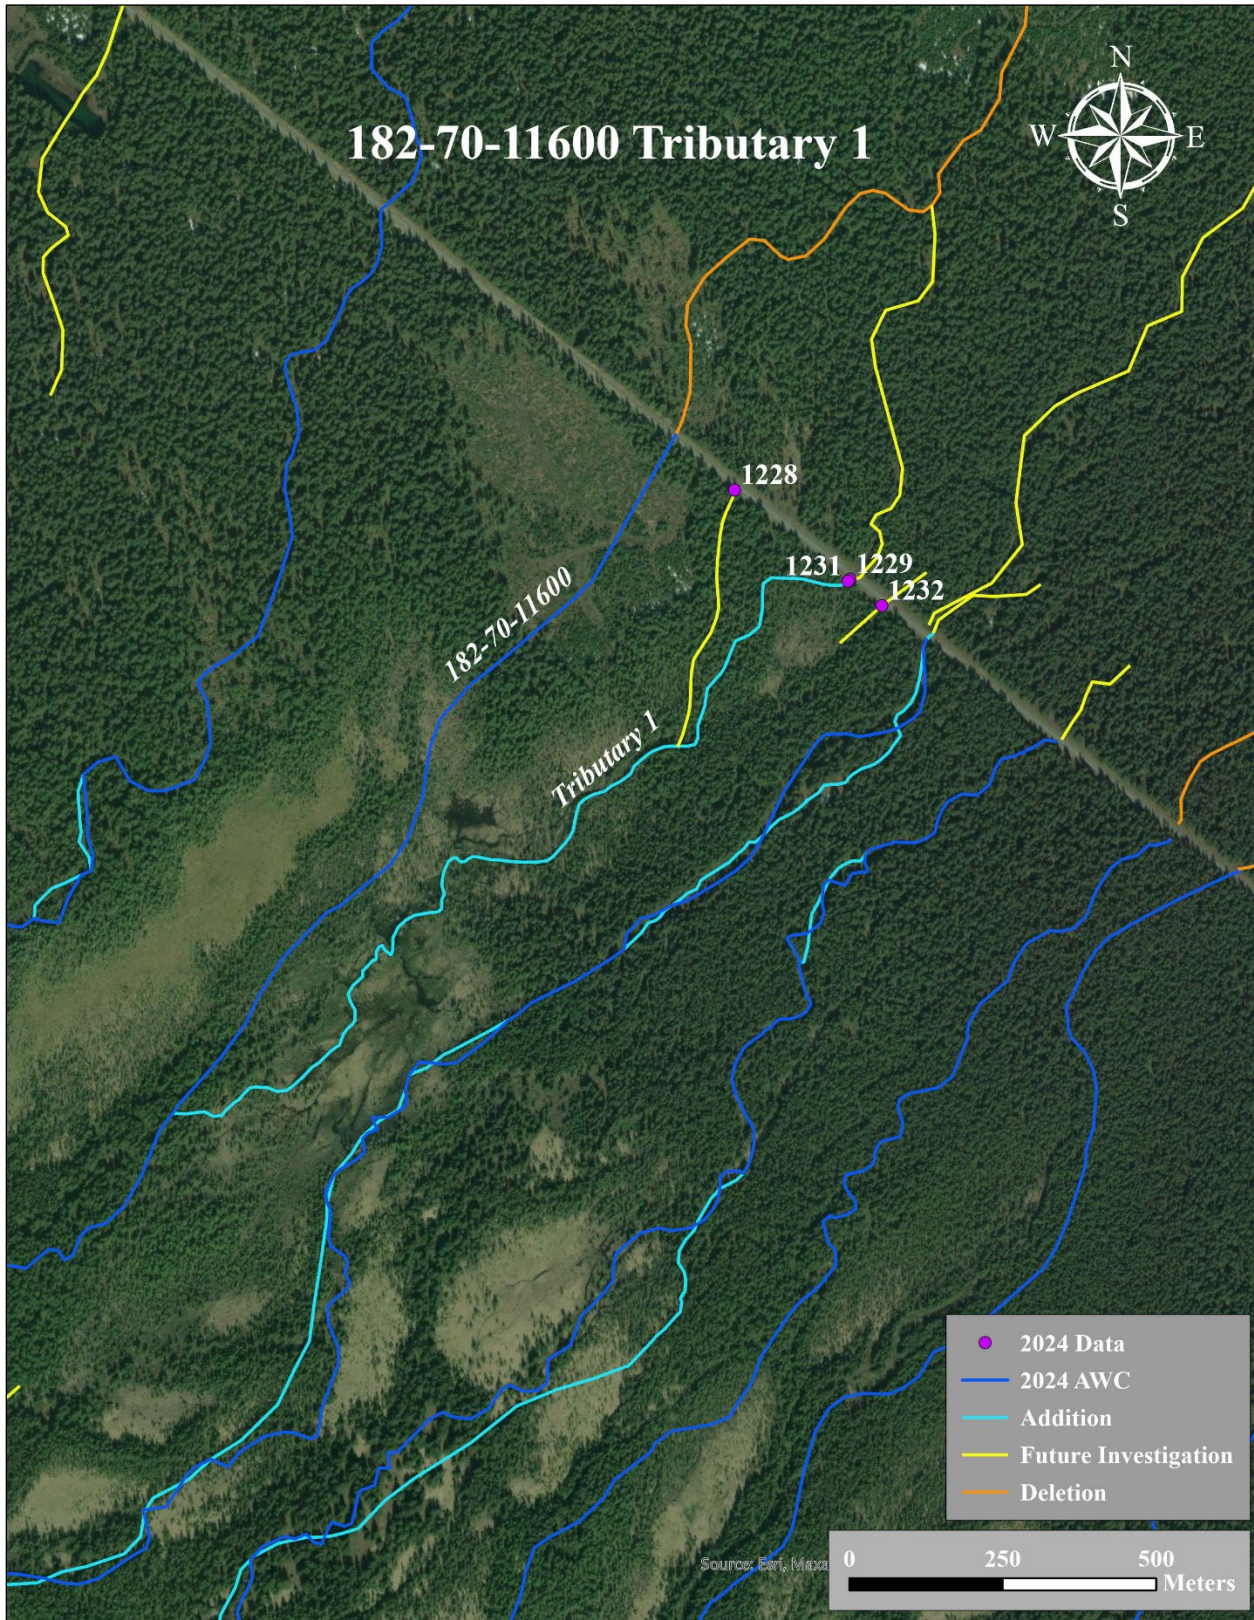
Figure 4.—182-70-11600 tributary 1 addition map.

**Recommendations:** Add this uncataloged stream to the anadromous waters catalog for rearing coho salmon (Figure 4).
