# Alaska Department of Fish and Game

## 106-22-10080 Tributary 6

## ADDITION

**Water body name:** Marin Creek

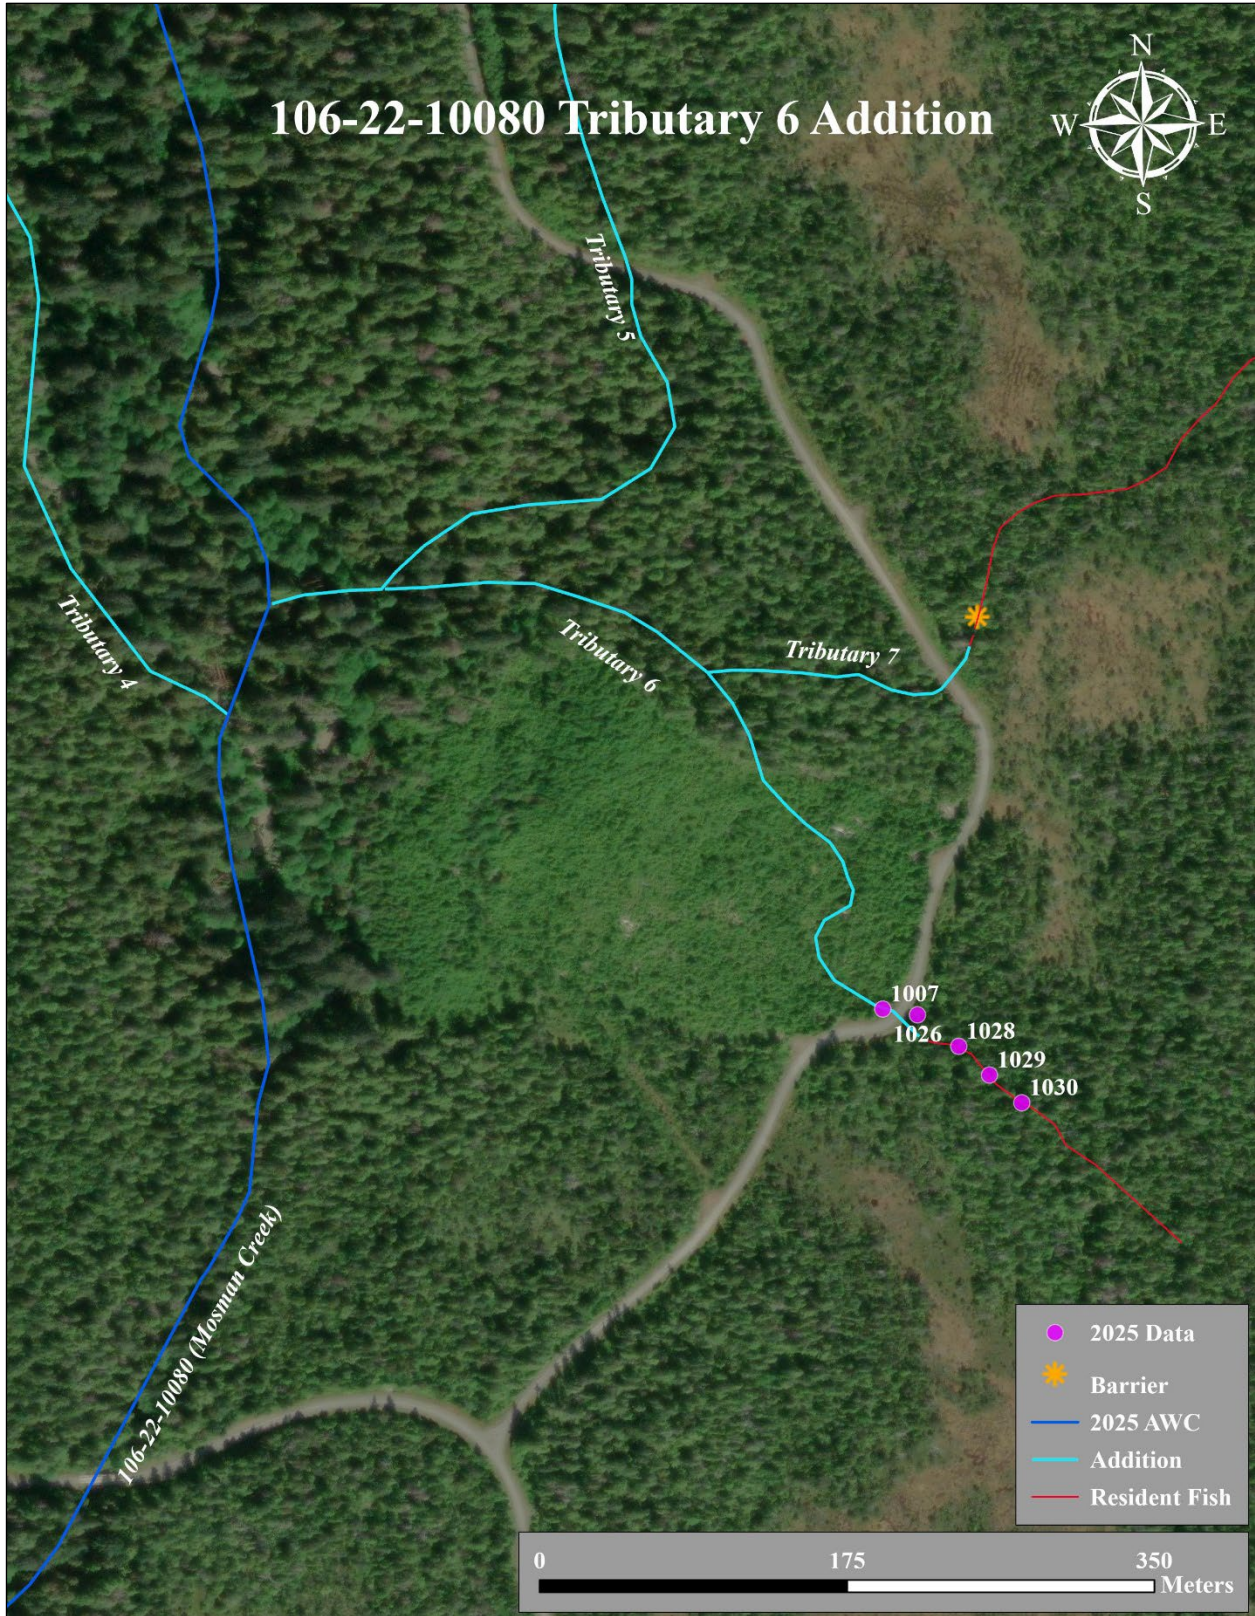
Figure 4.—106-22-10080 Tributary 6 Addition map.

**Recommendations:** Add this uncataloged stream to the anadromous waters catalog up to waypoint 1026 for rearing coho salmon (Figure 4).
