State of Alaska
Department of Fish and Game
Sportfish Division

Nomination Form
Anadromous Waters Catalog

Anadromous Waters Catalog Number of Water Body 191-20-13700-2003

191-20-13700 Tributary 1

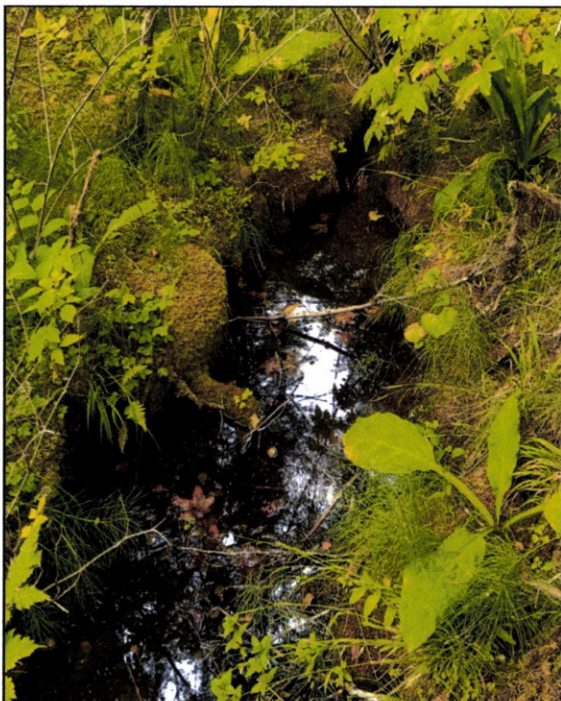
Figure 2.—Looking upstream at waypoint 727.

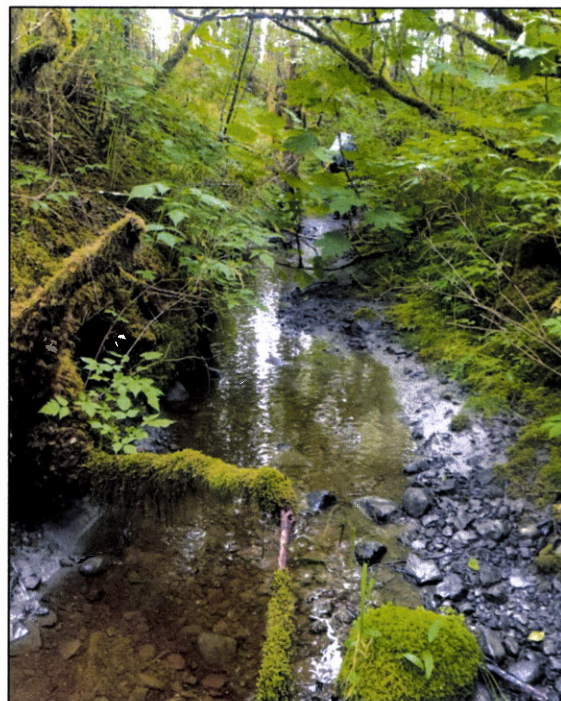
Figure 3.—Looking downstream at waypoint 700.

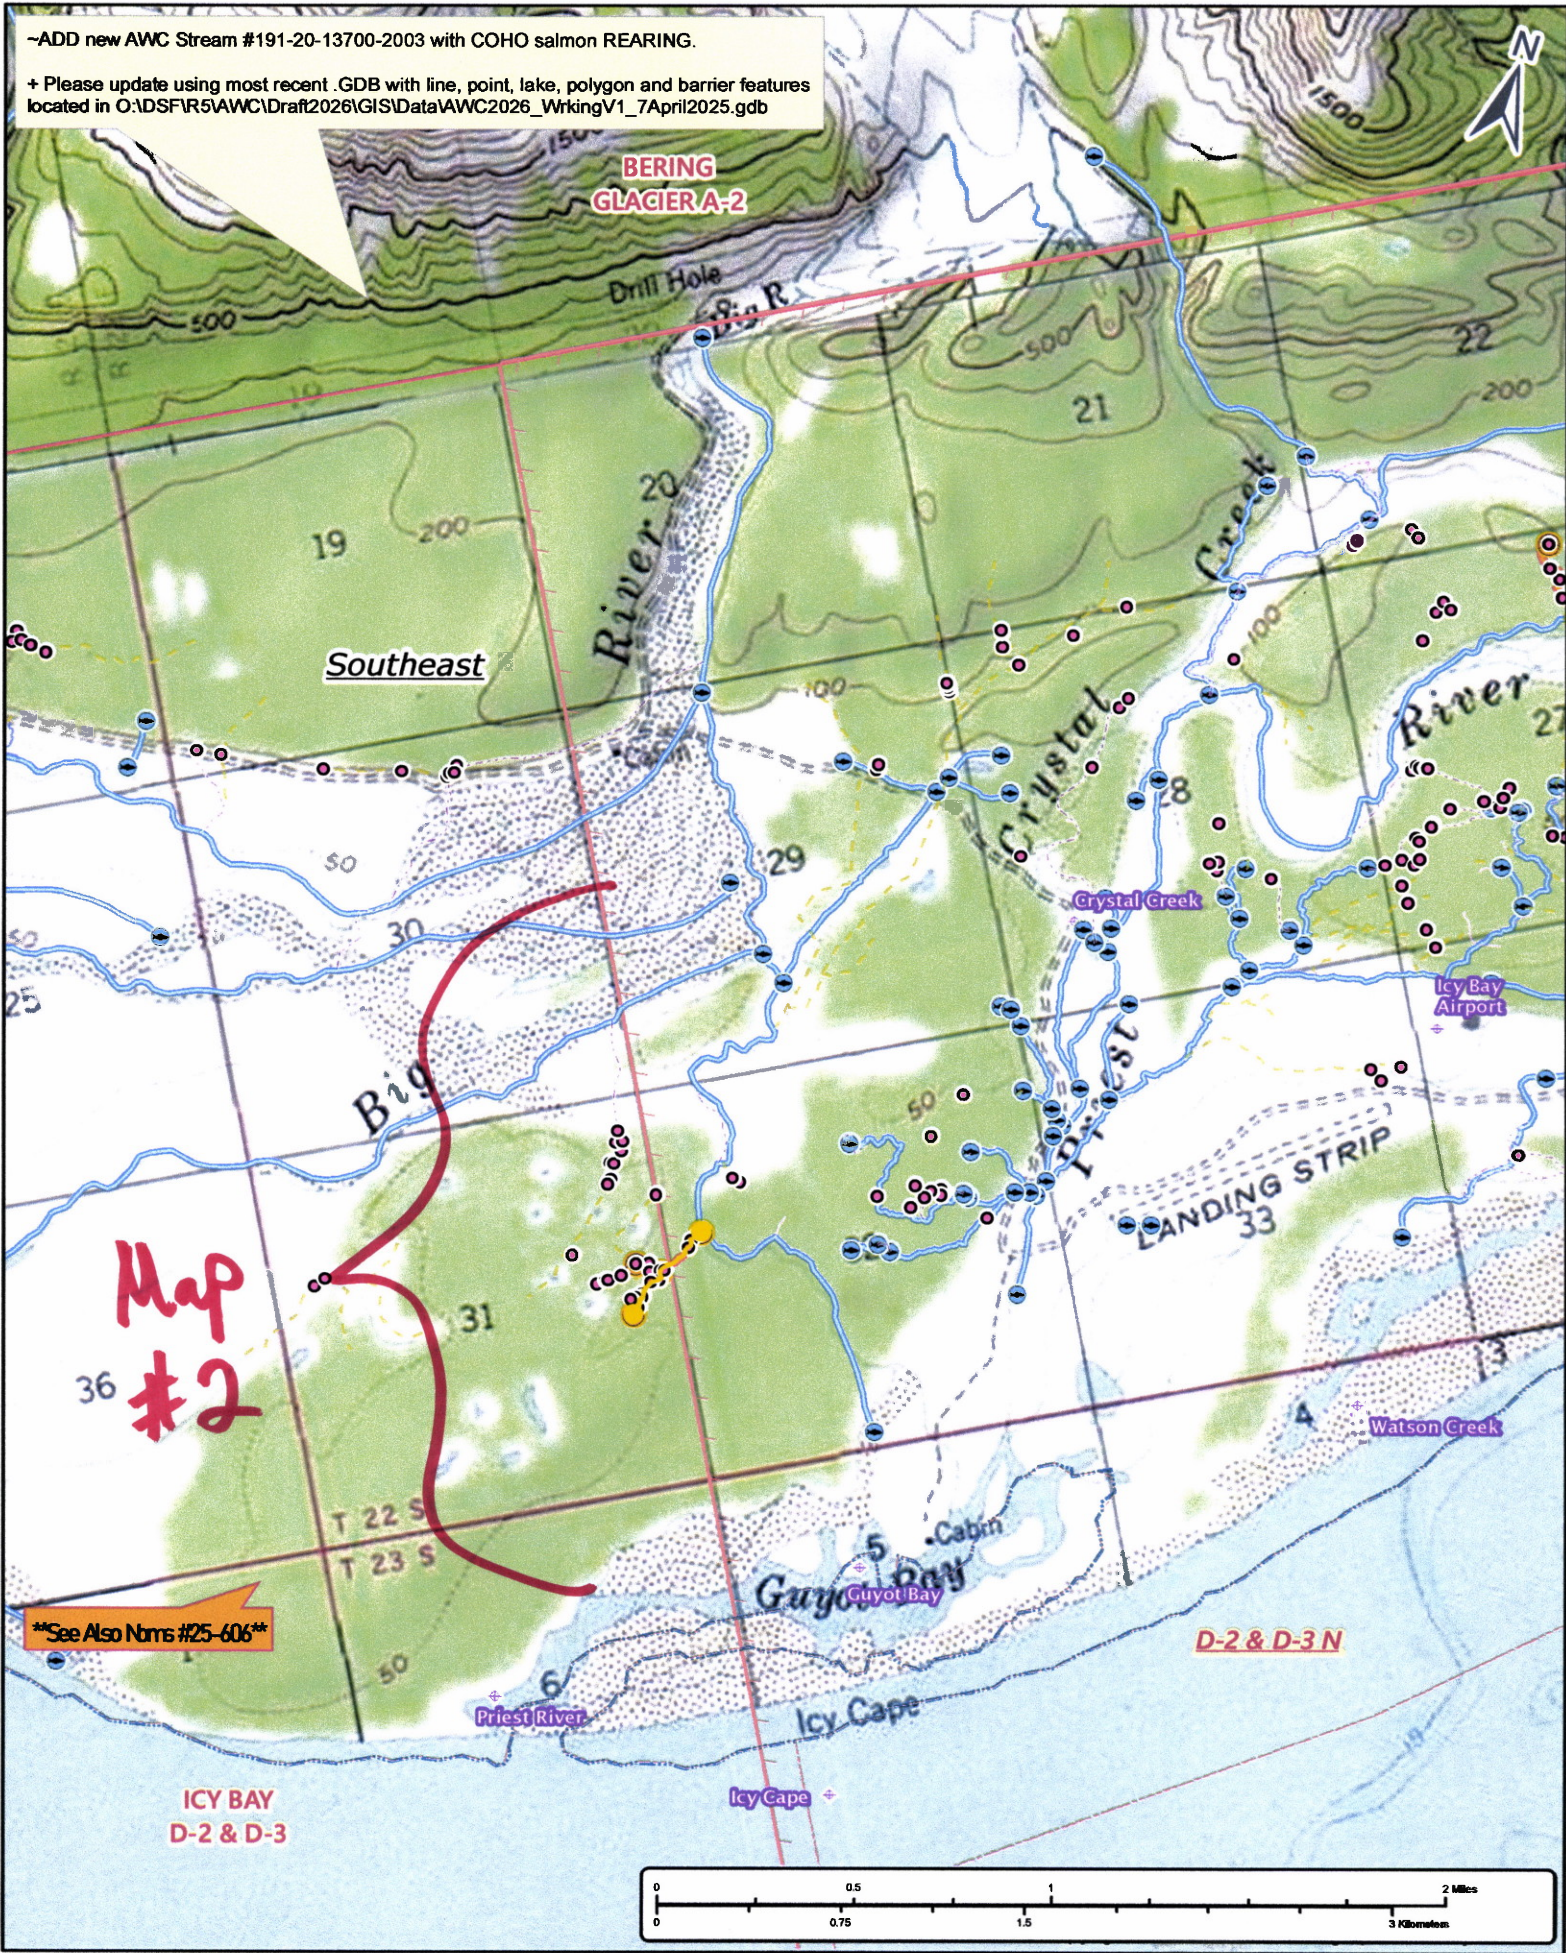
Map #1

~ADD new AWC Stream #191-20-13700-2003 with COHO salmon REARING.

+ Please update using most recent .GDB with line, point, lake, polygon and barrier features located in O:\DSFR5\AWC\Draft2026\GISData\AWC2026_WrkingV1_7April2025.gdb
