**Nomination Form
Anadromous Waters Catalog**

Anadromous Waters Catalog Number of Water Body 106-22-10080-2004

106-22-10080 Tributary 1

ADDITION

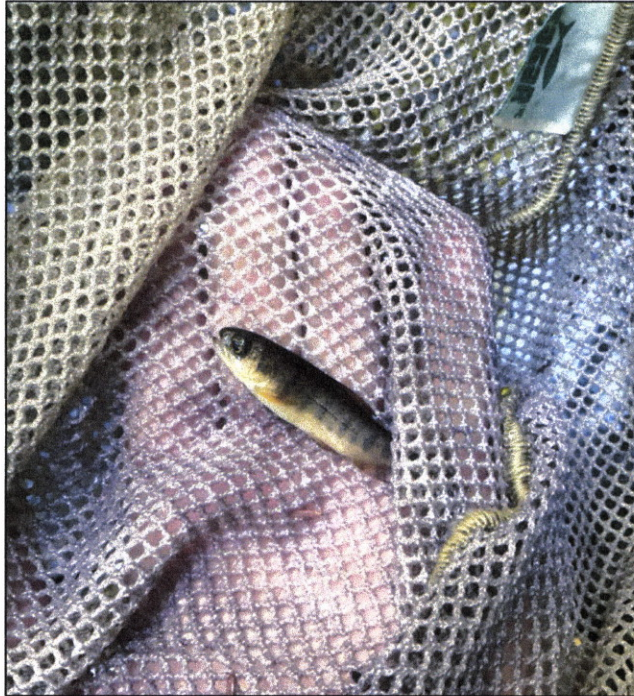
Figure 1.—Juvenile coho salmon caught at waypoint 1041.

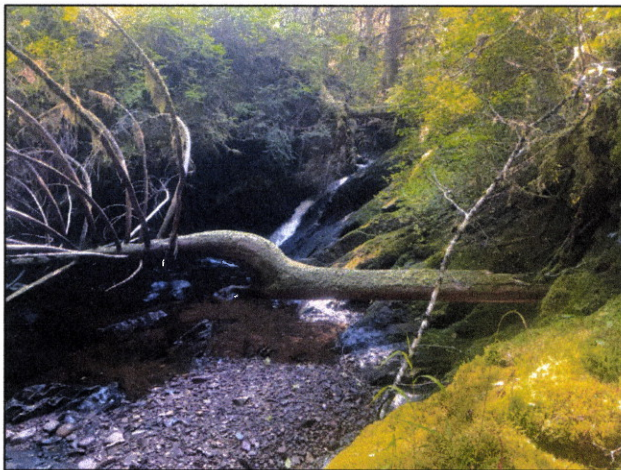
Findings: We surveyed this uncataloged stream up to an anadromous fish barrier using a backpack electrofisher and GPS and captured juvenile coho salmon, Dolly Varden, rainbow trout and visually identified adult pink salmon both schooled up and spawning. The barrier is a narrow 6 ft bedrock cascade with a 1 ft deep jump pool at its base, which constitutes a permanent rock barrier. Adult pink salmon were seen in a pool just downstream. Only resident fish were caught above the bedrock cascade. The stream is highly incised both upstream and downstream of the barrier but still provides fish spawning and rearing habitat (Table 1; Figures 1–3).

Figure 2.—Bedrock falls barrier at waypoint 1041.

Recommendations: Add this uncataloged stream to the anadromous waters catalog up to waypoint 1041 for rearing coho salmon and spawning pink salmon, and add barrier point at waypoint 1041 (Figure 4).

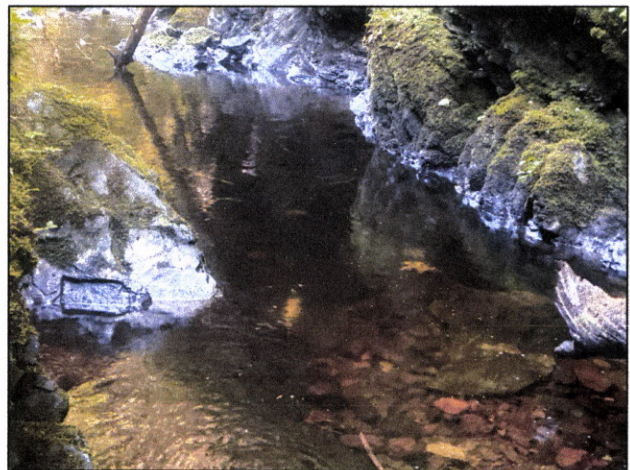
Figure 3.—Channel with adult pink salmon present at waypoint 1041.

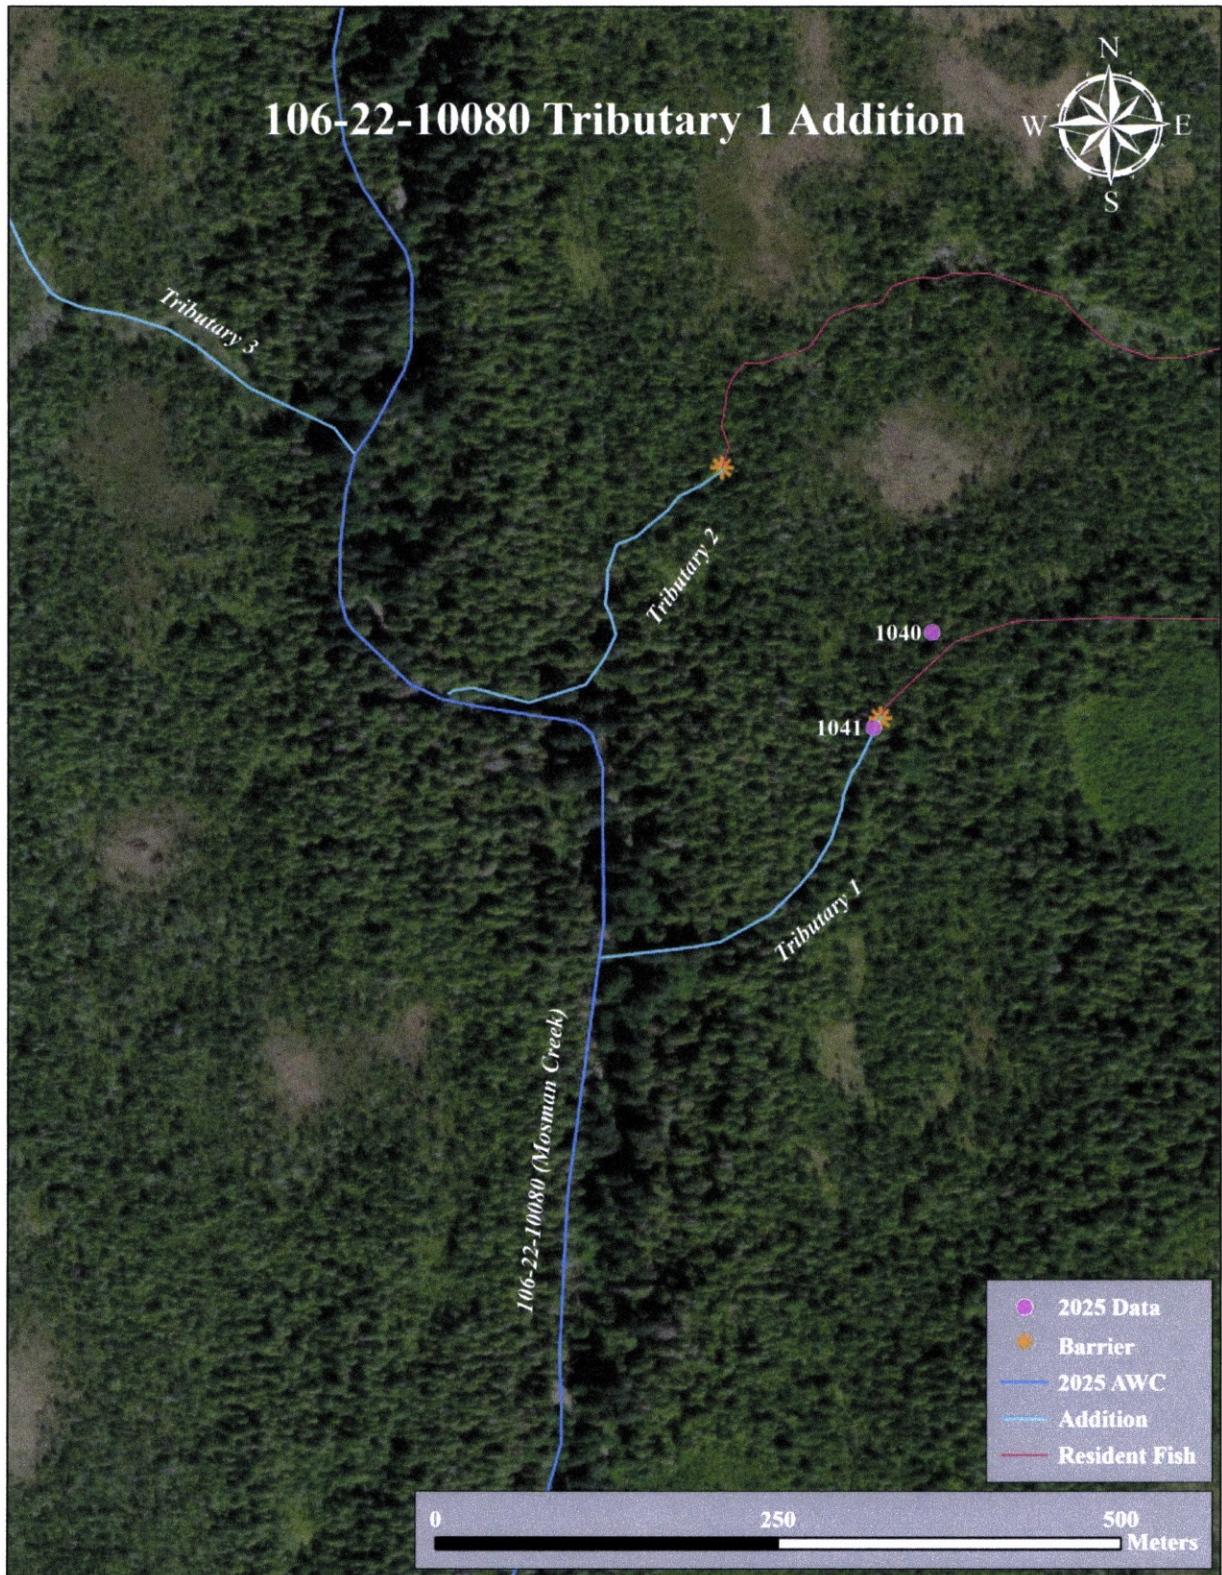
Figure 4.-106-22-10080 Tributary 1 Addition map.

~ADD new AWC Stream #106-22-10080-2004 with COHO salmon REARING and PINK salmon SPAWNING.
 ~ADD new BARRIER above new AWC Stream #106-22-10080-2004.
 + Please update using most recent .GDB with line, point, lake, polygon and barrier features located in O:\DS\FR5\AWC\Draft2026\GIS\Data\AWC2026_WorkingV1_7April2025.gdb
