**State of Alaska
Department of Fish and Game
Sportfish Division**

**Nomination Form
Anadromous Waters Catalog**

Region Southwestern USGS Quad(s) KODIAK D-2 (SE) & (SW)
 Anadromous Waters Catalog Number of Water Body 259-21-10120 (-2006) (-2003)
 Name of Water Body Buskin River USGS Name Local Name
 Addition Deletion Correction Backup Information

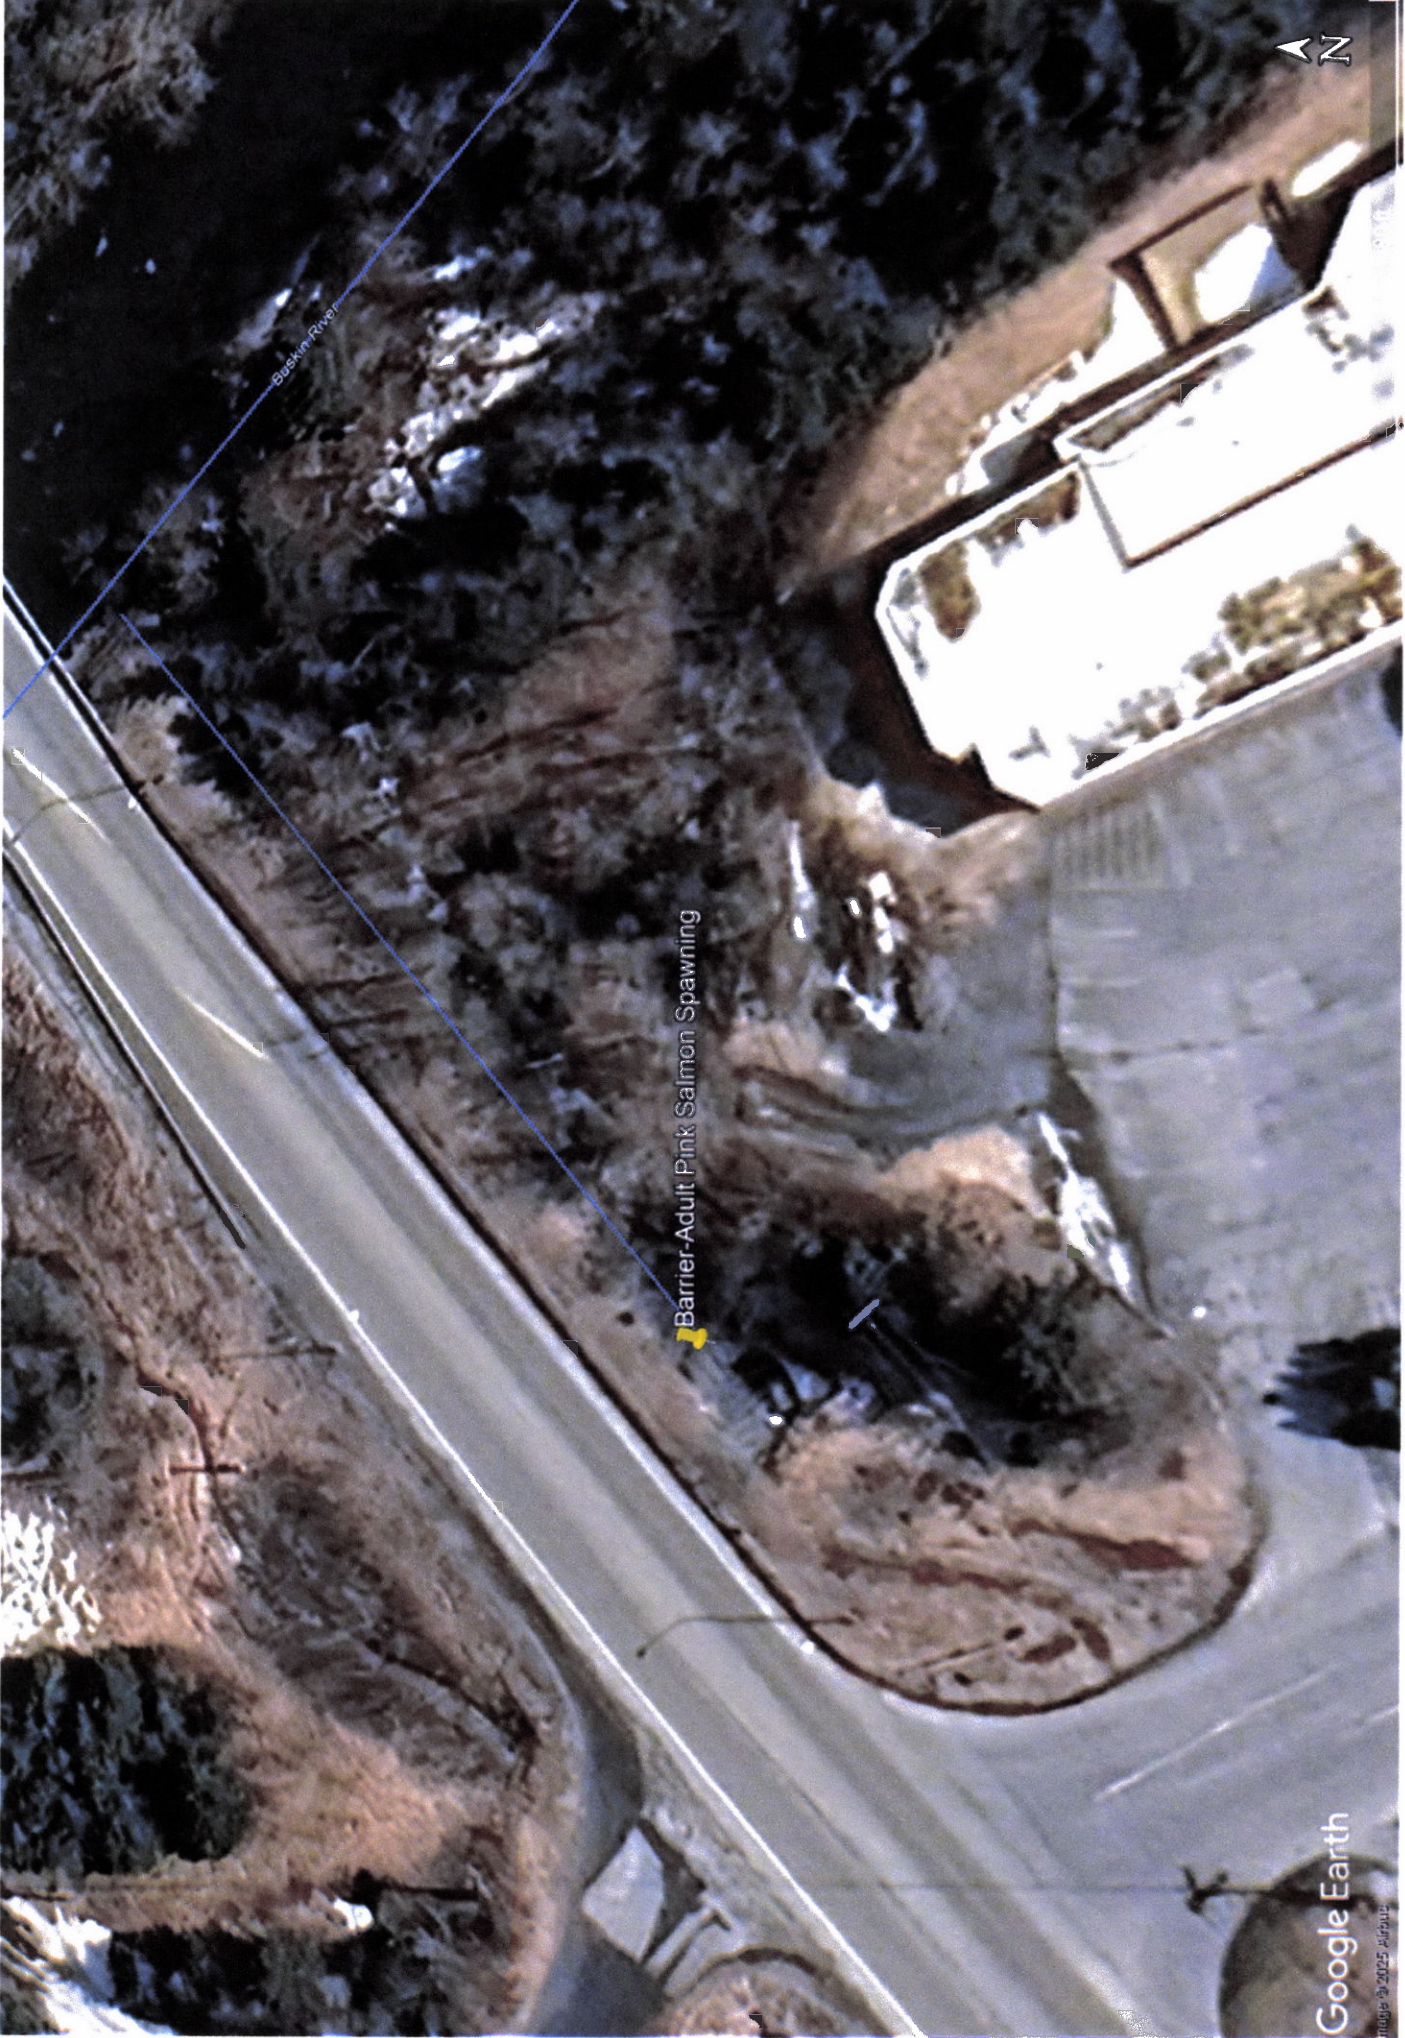
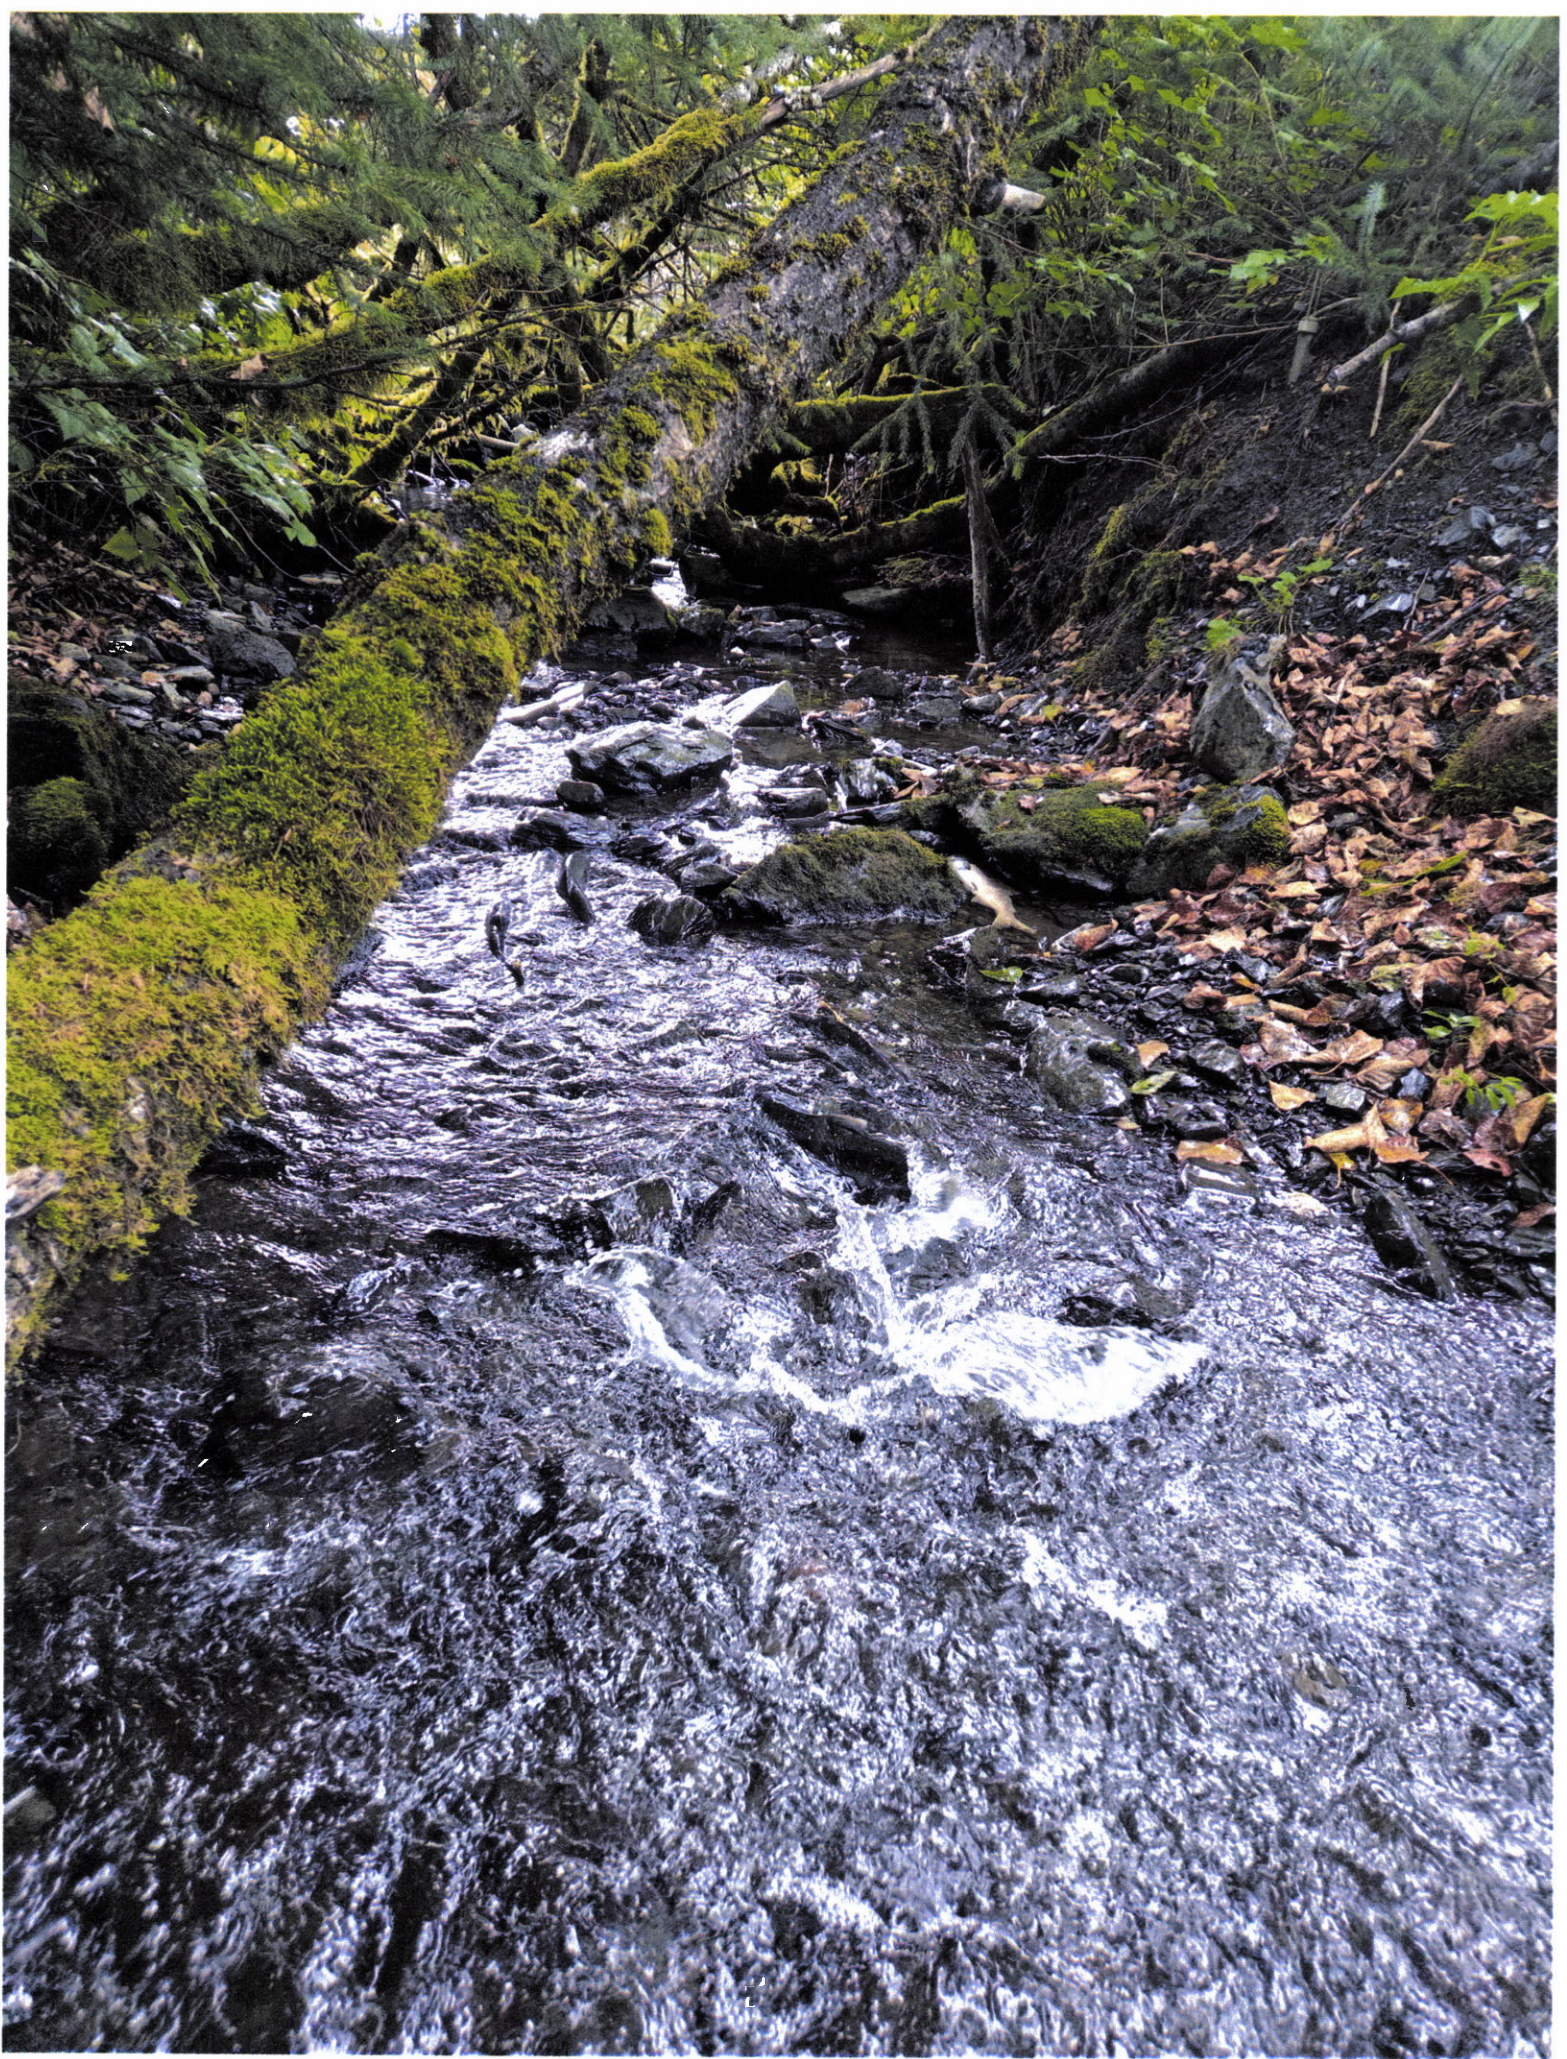
I observed about 300 adult pink salmon spawning in a 75 meter long unnamed tributary to the Buskin River (Figures 1 and 2). The stream is located between Rezanof Drive and the Quality Inn/Buskin River Inn. Spawning habitat ended at a riprap barrier placed in the stream about 5 meters downstream of a perched culvert located under Airport Way (Figures 3 and 4). The barrier and fish spawning is located at about 57.7567, -152.5156.
 Coordinates (Lat,Long): Upper(57.7567,-152.5156) Lower(57.7572,-152.5147)

~UPDATE/ADJUST hydrography segment of existing AWC Stream #259-21-10120 "Buskin River".
 ~UPDATE/RELOCATE stream mouth point of existing AWC Stream #259-21-10120-2006.
 ~ADD new AWC Stream #259-21-10120-2003 with PINK salmon SPAWNING.
 ~ADD new BARRIER above new AWC Stream #259-21-10120-2003.
