# Alaska Department of Fish and Game

**182-70-12000-2022-3011**

**ADDITION**

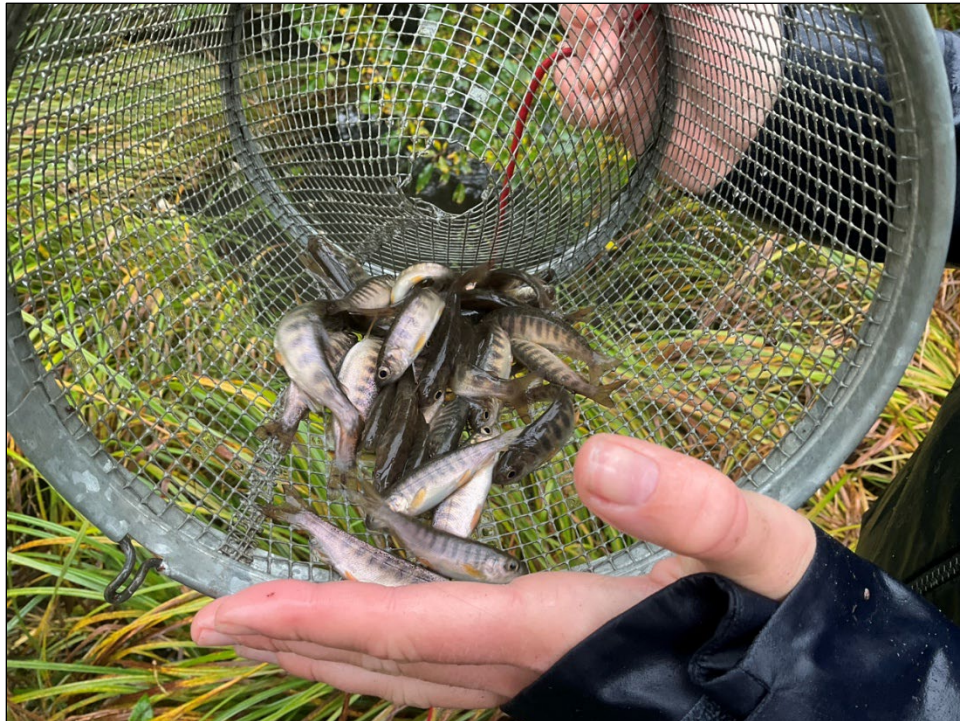
Figure 1.—Juvenile coho salmon captured at waypoint 1249.

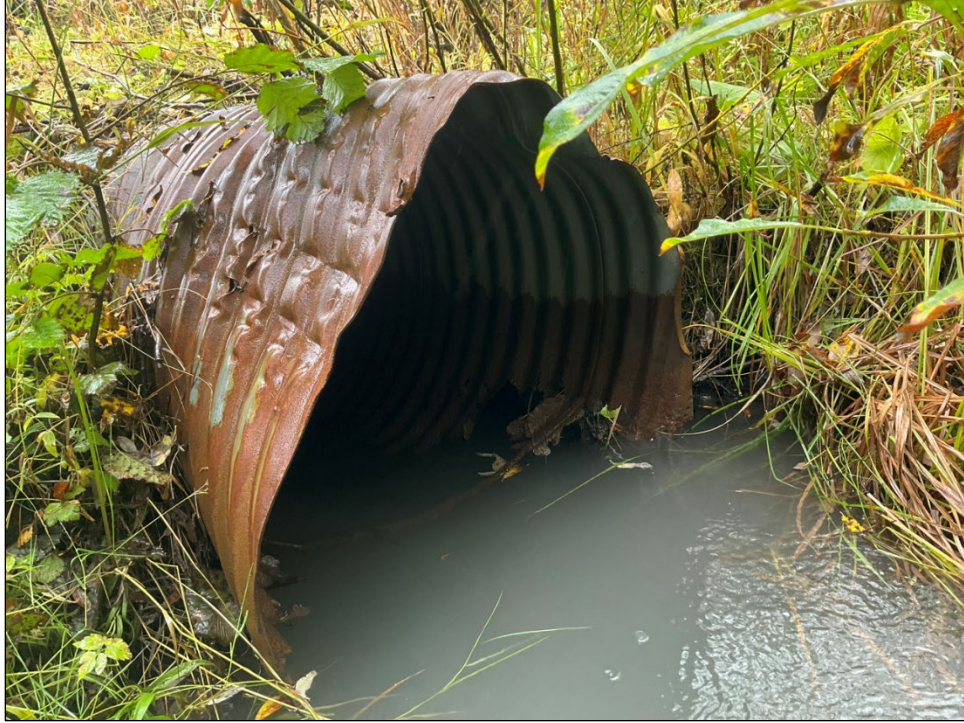
**Findings:** We surveyed this uncataloged stream from the road using baited minnow traps and GPS and captured juvenile coho salmon (Figure 1). The stream is low gradient, the channel is poorly defined upstream of the road, and culvert is in poor condition (Table 1; Figures 2, 3).

| Waypoint | Latitude | Longitude | Notes | Stream Width ft | Stream Substrate | Habitat Features | Gradient % | Sample Effort | Sample Results |
|---|---|---|---|---|---|---|---|---|---|
| 1249 | 59.453170 | -139.068256 | Minnow trap set upstream of 3 ft CMP, fully rusted, bottom falling out and pipe collapsing on both sides, especially at inlet. | 4-6 | Fine Organic | | 1-2 | MT | 29 CO |

Figure 2.–Culvert inlet at waypoint 1249.

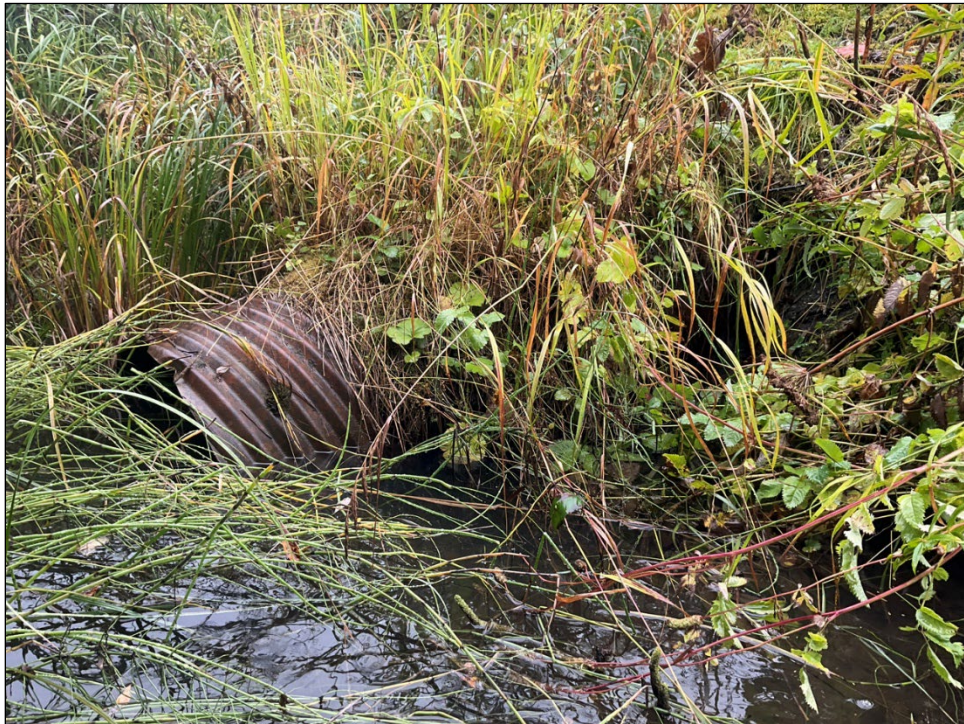
Figure 3.–Culvert outlet at waypoint 1249.
