# Alaska Department of Fish and Game

**186-15-10550-2005-3002-4012**

**ADDITION**

**Survey date:** 8/20/2024

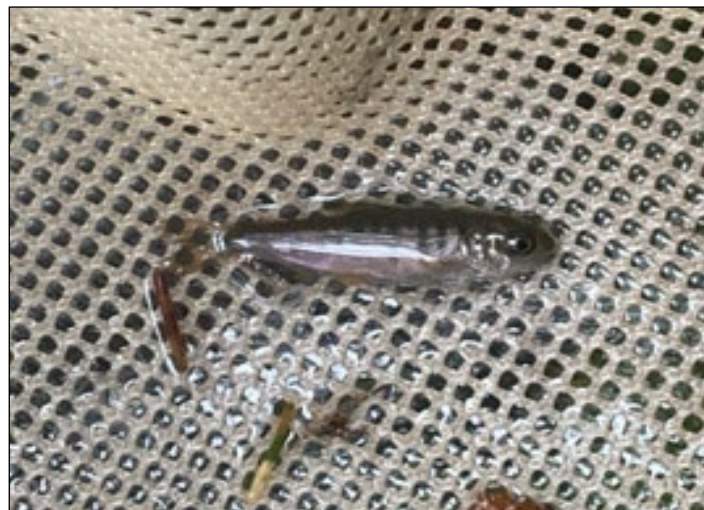
| Waypoint | Latitude | Longitude | Notes | Stream Width ft | Stream Substrate | Habitat Features | Gradient % | Sample Effort | Sample Results |
|---|---|---|--|---|---|---|---|---|---|
| 1047 | 59.987480 | -141.523720 | Channel continues uphill with little flowing water for approximately 100 to 150 feet. Then the channel dries out as a continues uphill at a steady gradient of 4 to 5%. CO caught in section of channel with water just downstream of point. | | Cobble | | 4-6 | EF | |

Figure 1.–Juvenile coho salmon caught at waypoint 1047.

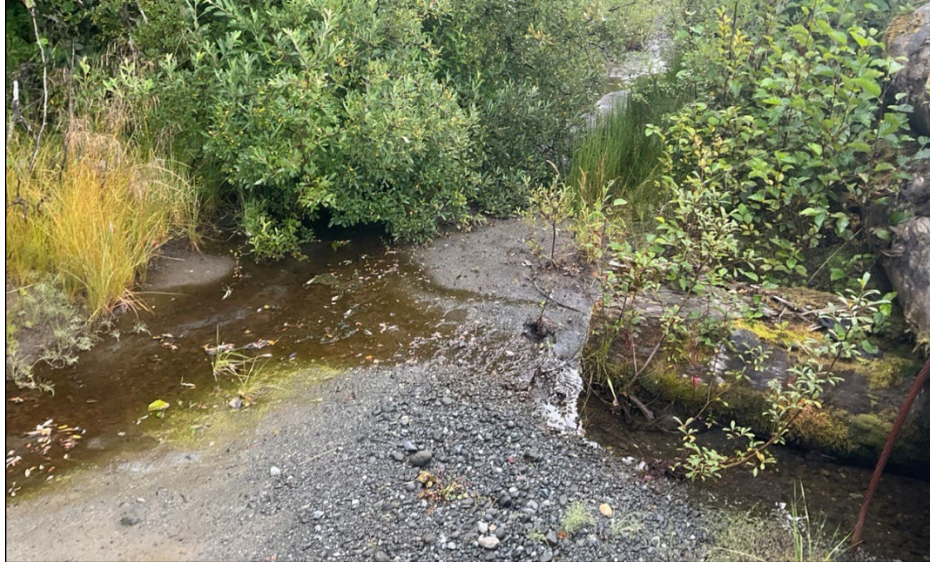
| Waypoint | Latitude | Longitude | Notes | Stream Width ft | Stream Substrate | Habitat Features | Gradient % | Sample Effort | Sample Results |
|---|---|---|--|---|---|---|---|---|---|
| 1046 | 59.987137 | -141.523637 | Coho caught in pool just upstream of the bridge and others visually seen. The ditch further west continues up through this point and continues going east. Only small amount of water falling under the bridge to low water levels. | | Small Gravel | | 1-2 | EF | 2 CO |

1046. Figure 2.—Confluence of the stream and ditch, just above the bridge at waypoint

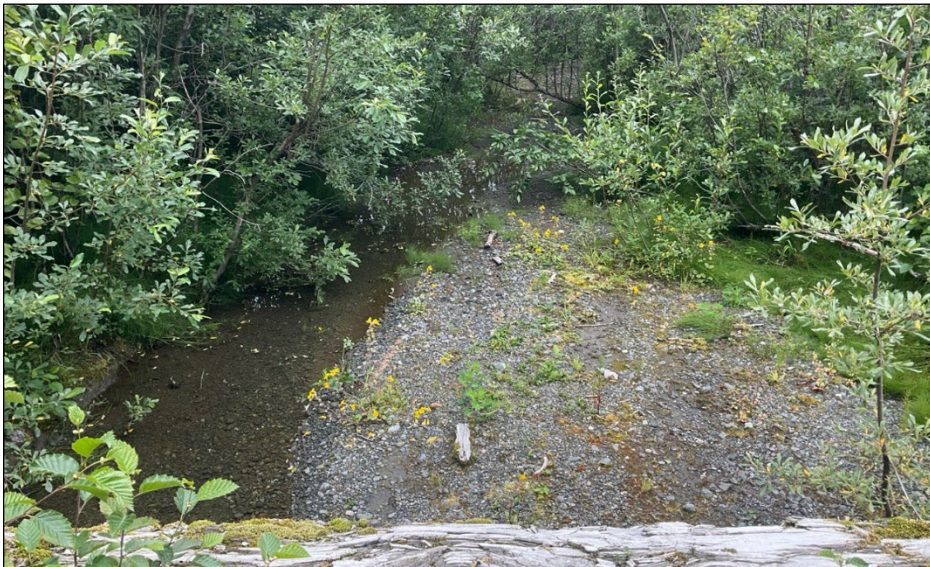
**Findings:** We surveyed this cataloged stream using a backpack electrofisher and GPS and captured juvenile coho salmon. This stream goes under a bridge with lots of material deposition. Gradient increases quickly above road, with water flow dissipating as elevation increases. Survey ended when channel went dry, but fish habitat could continue at this gradient during higher water (Table 1; Figures 1–3).

Figure 3.—Looking downstream of the bridge.
