Alaska Department of Fish and Game

Habitat Section
Southeast Region

191-20-13800-2016 Tributary 1

ADDITION

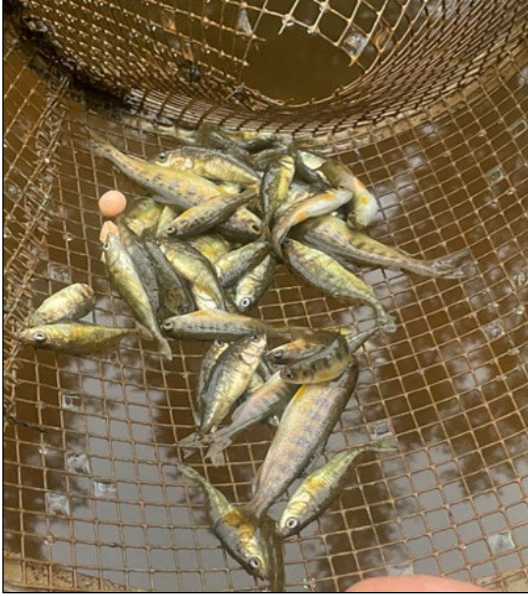
Figure 1.—Juvenile coho salmon caught at waypoint 764.

| Waypoint | Latitude | Longitude | Notes | Stream Width ft | Stream Substrate | Habitat Features | Gradient % | Sample Effort | Sample Results |
|---|---|---|--|---|---|---|---|---|---|
| 764 | 59.977088 | -141.638299 | The second puncheon is set over stream just below road and leads to small pond setting, minnow trap in pond. Multiple age class coho caught in pond below road. | | | | | MT | 11 CO 10 SB |

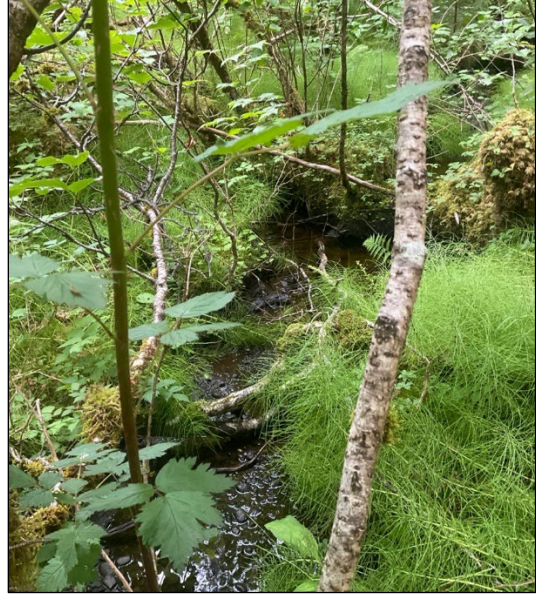
Figure 2.—Looking upstream at waypoint 763.

| Waypoint | Latitude | Longitude | Notes | Stream Width ft | Stream Substrate | Habitat Features | Gradient % | Sample Effort | Sample Results |
|---|---|---|--|---|---|---|---|---|---|
| 763 | 59.977746 | -141.637350 | Stream continues up this direction in narrows up to approximately 3 feet wide and still flowing. Seems like decent fish habitat unsure if fish can get up this far due to puncheon in road. | | Small Gravel | | 1-2 | | |

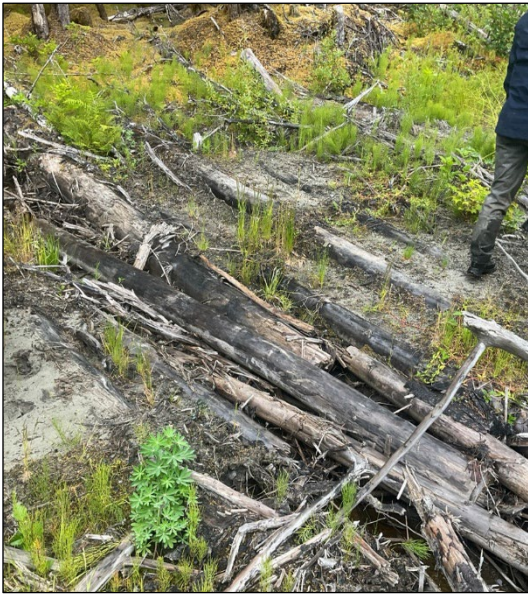
Figure 3.—Puncheon across the road at waypoint 762.

Findings: We surveyed this uncataloged stream using baited minnow traps and GPS and captured juvenile coho salmon and stickleback. This stream flows southwest and crosses the road through puncheon; very little flow actually making it through. Fish habitat continues upstream but no fish found, possibly due to the puncheon acting as a barrier. Ponedged water below the road and puncheon (Table 1; Figures 1–4).

| Waypoint | Latitude | Longitude | Notes | Stream Width ft | Stream Substrate | Habitat Features | Gradient % | Sample Effort | Sample Results |
|---|---|---|--|---|---|---|---|---|---|
| 762 | 59.977195 | -141.638331 | Stream crosses road at puncheon, very little water passing through puncheon, but still flowing through and heading east. Upstream there is a pond where the stream seems to seep from will be setting Minnow trap there. | | | | | | |

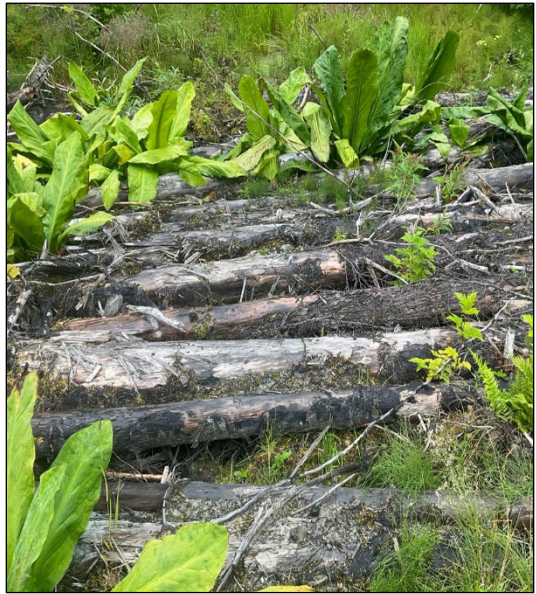
Figure 4.—Puncheon across the road at waypoint 764.

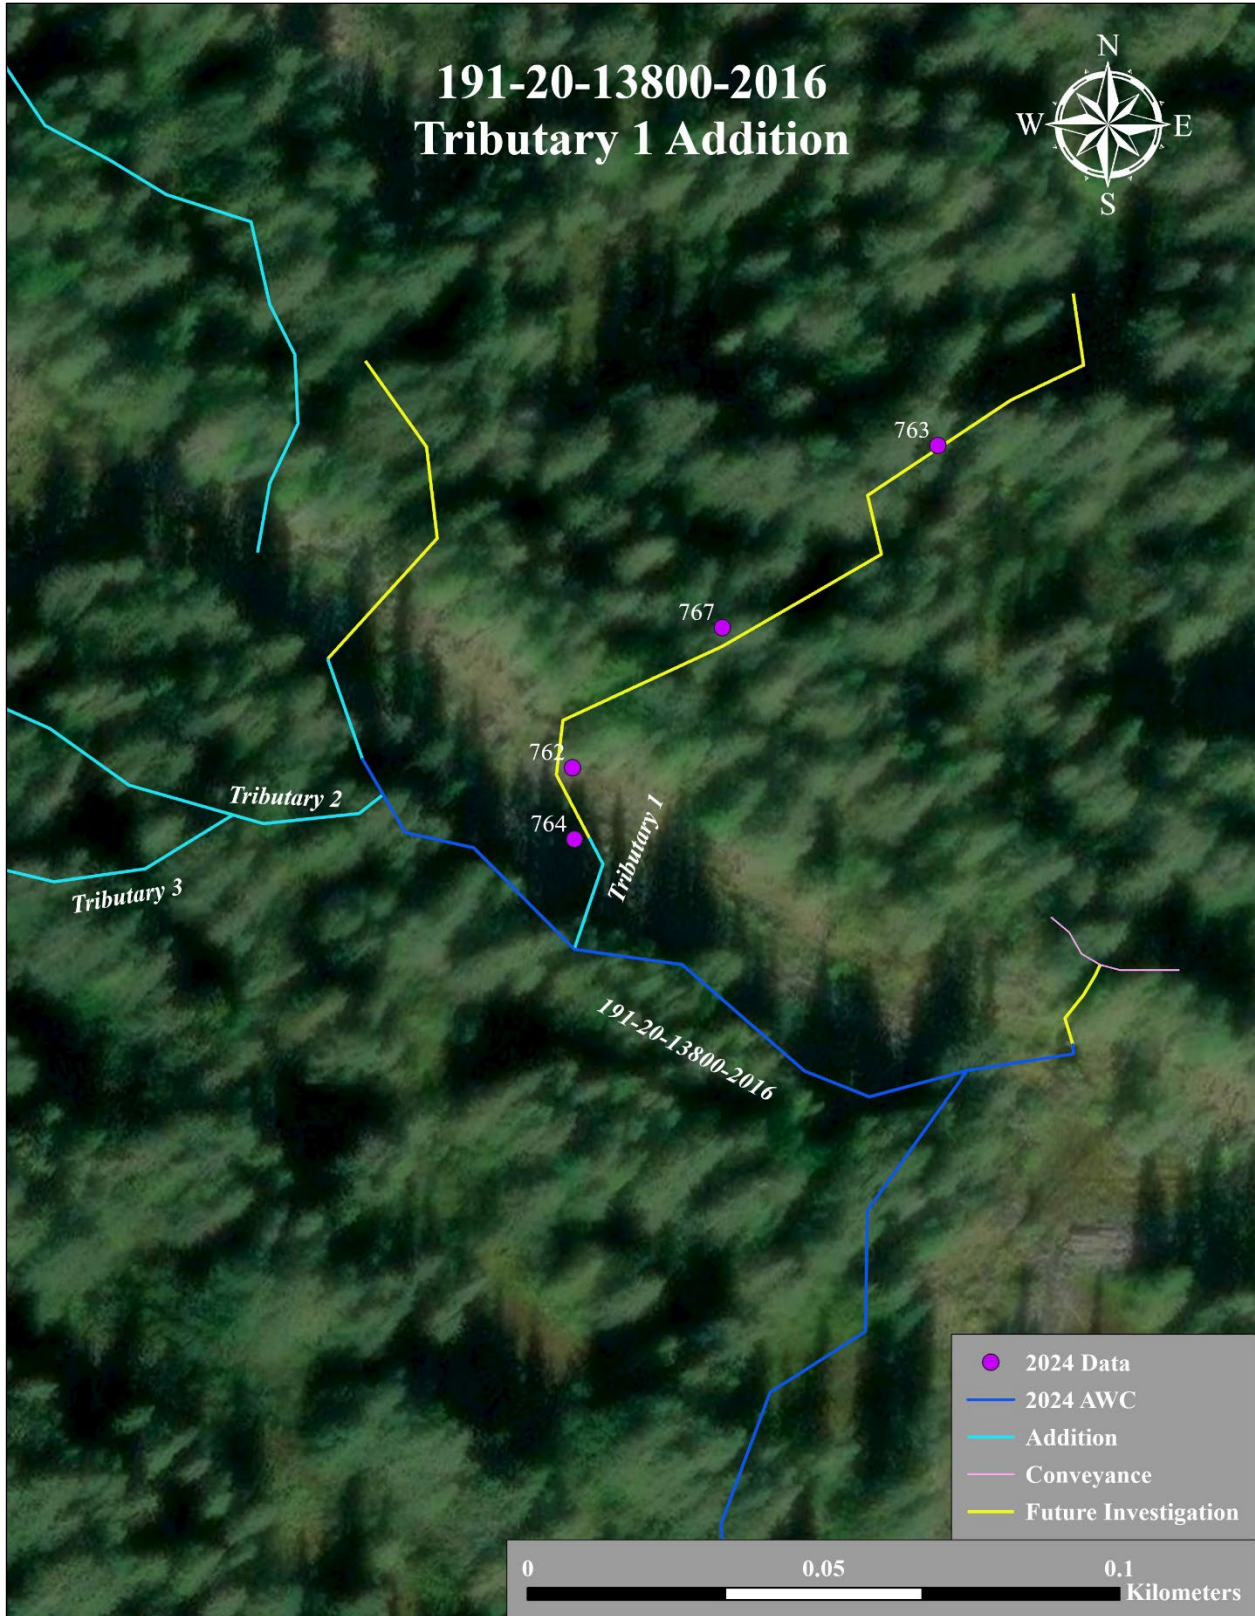
Figure 5.—191-20-13800-2016 tributary 1 addition map.

Recommendations: Add this uncataloged stream to the anadromous waters catalog for rearing coho salmon (Figure 5).
